# FIU PEDESTRIAN BRIDGE COLLAPSE

## AASHTO Committee on Construction VIRTUAL ANNUAL MEETING

Gary J. Klein, P.E., S.E. – Wiss, Janney, Elstner Associates, Inc.

August 13, 2020

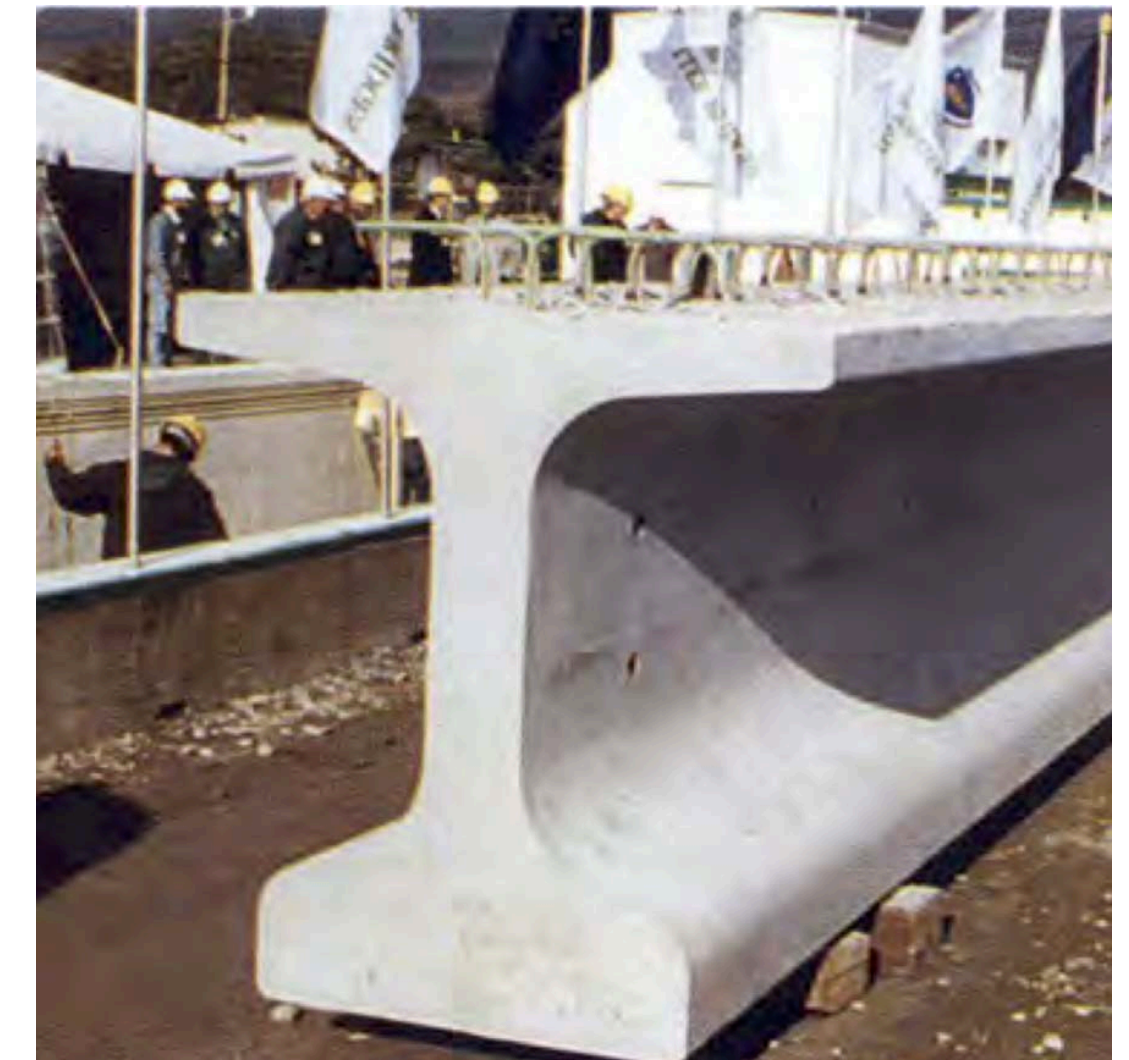
Typical Precast Concrete I-Beam

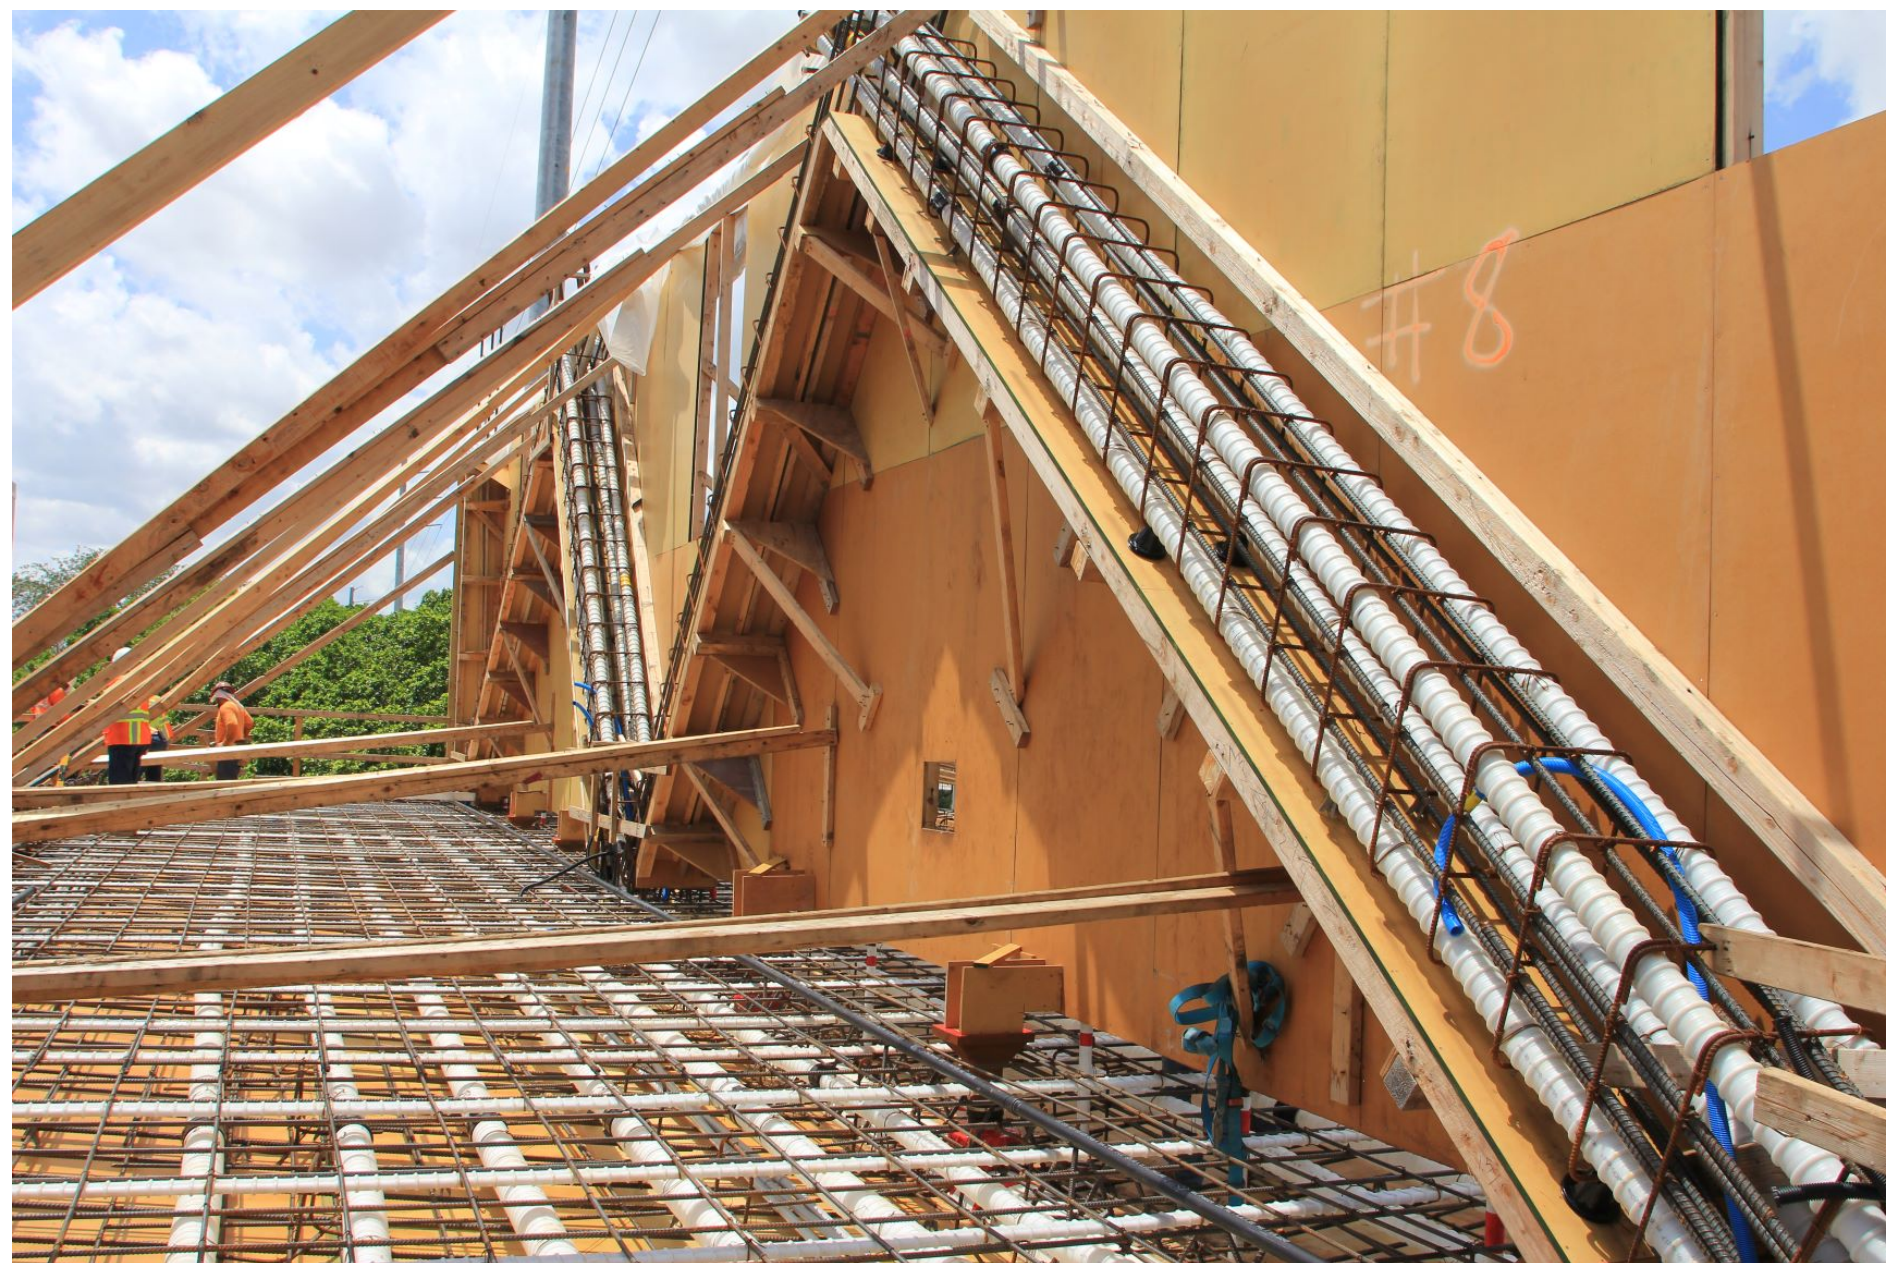
## Redundant features of FIU Pedestrian Bridge

Internal Redundancy

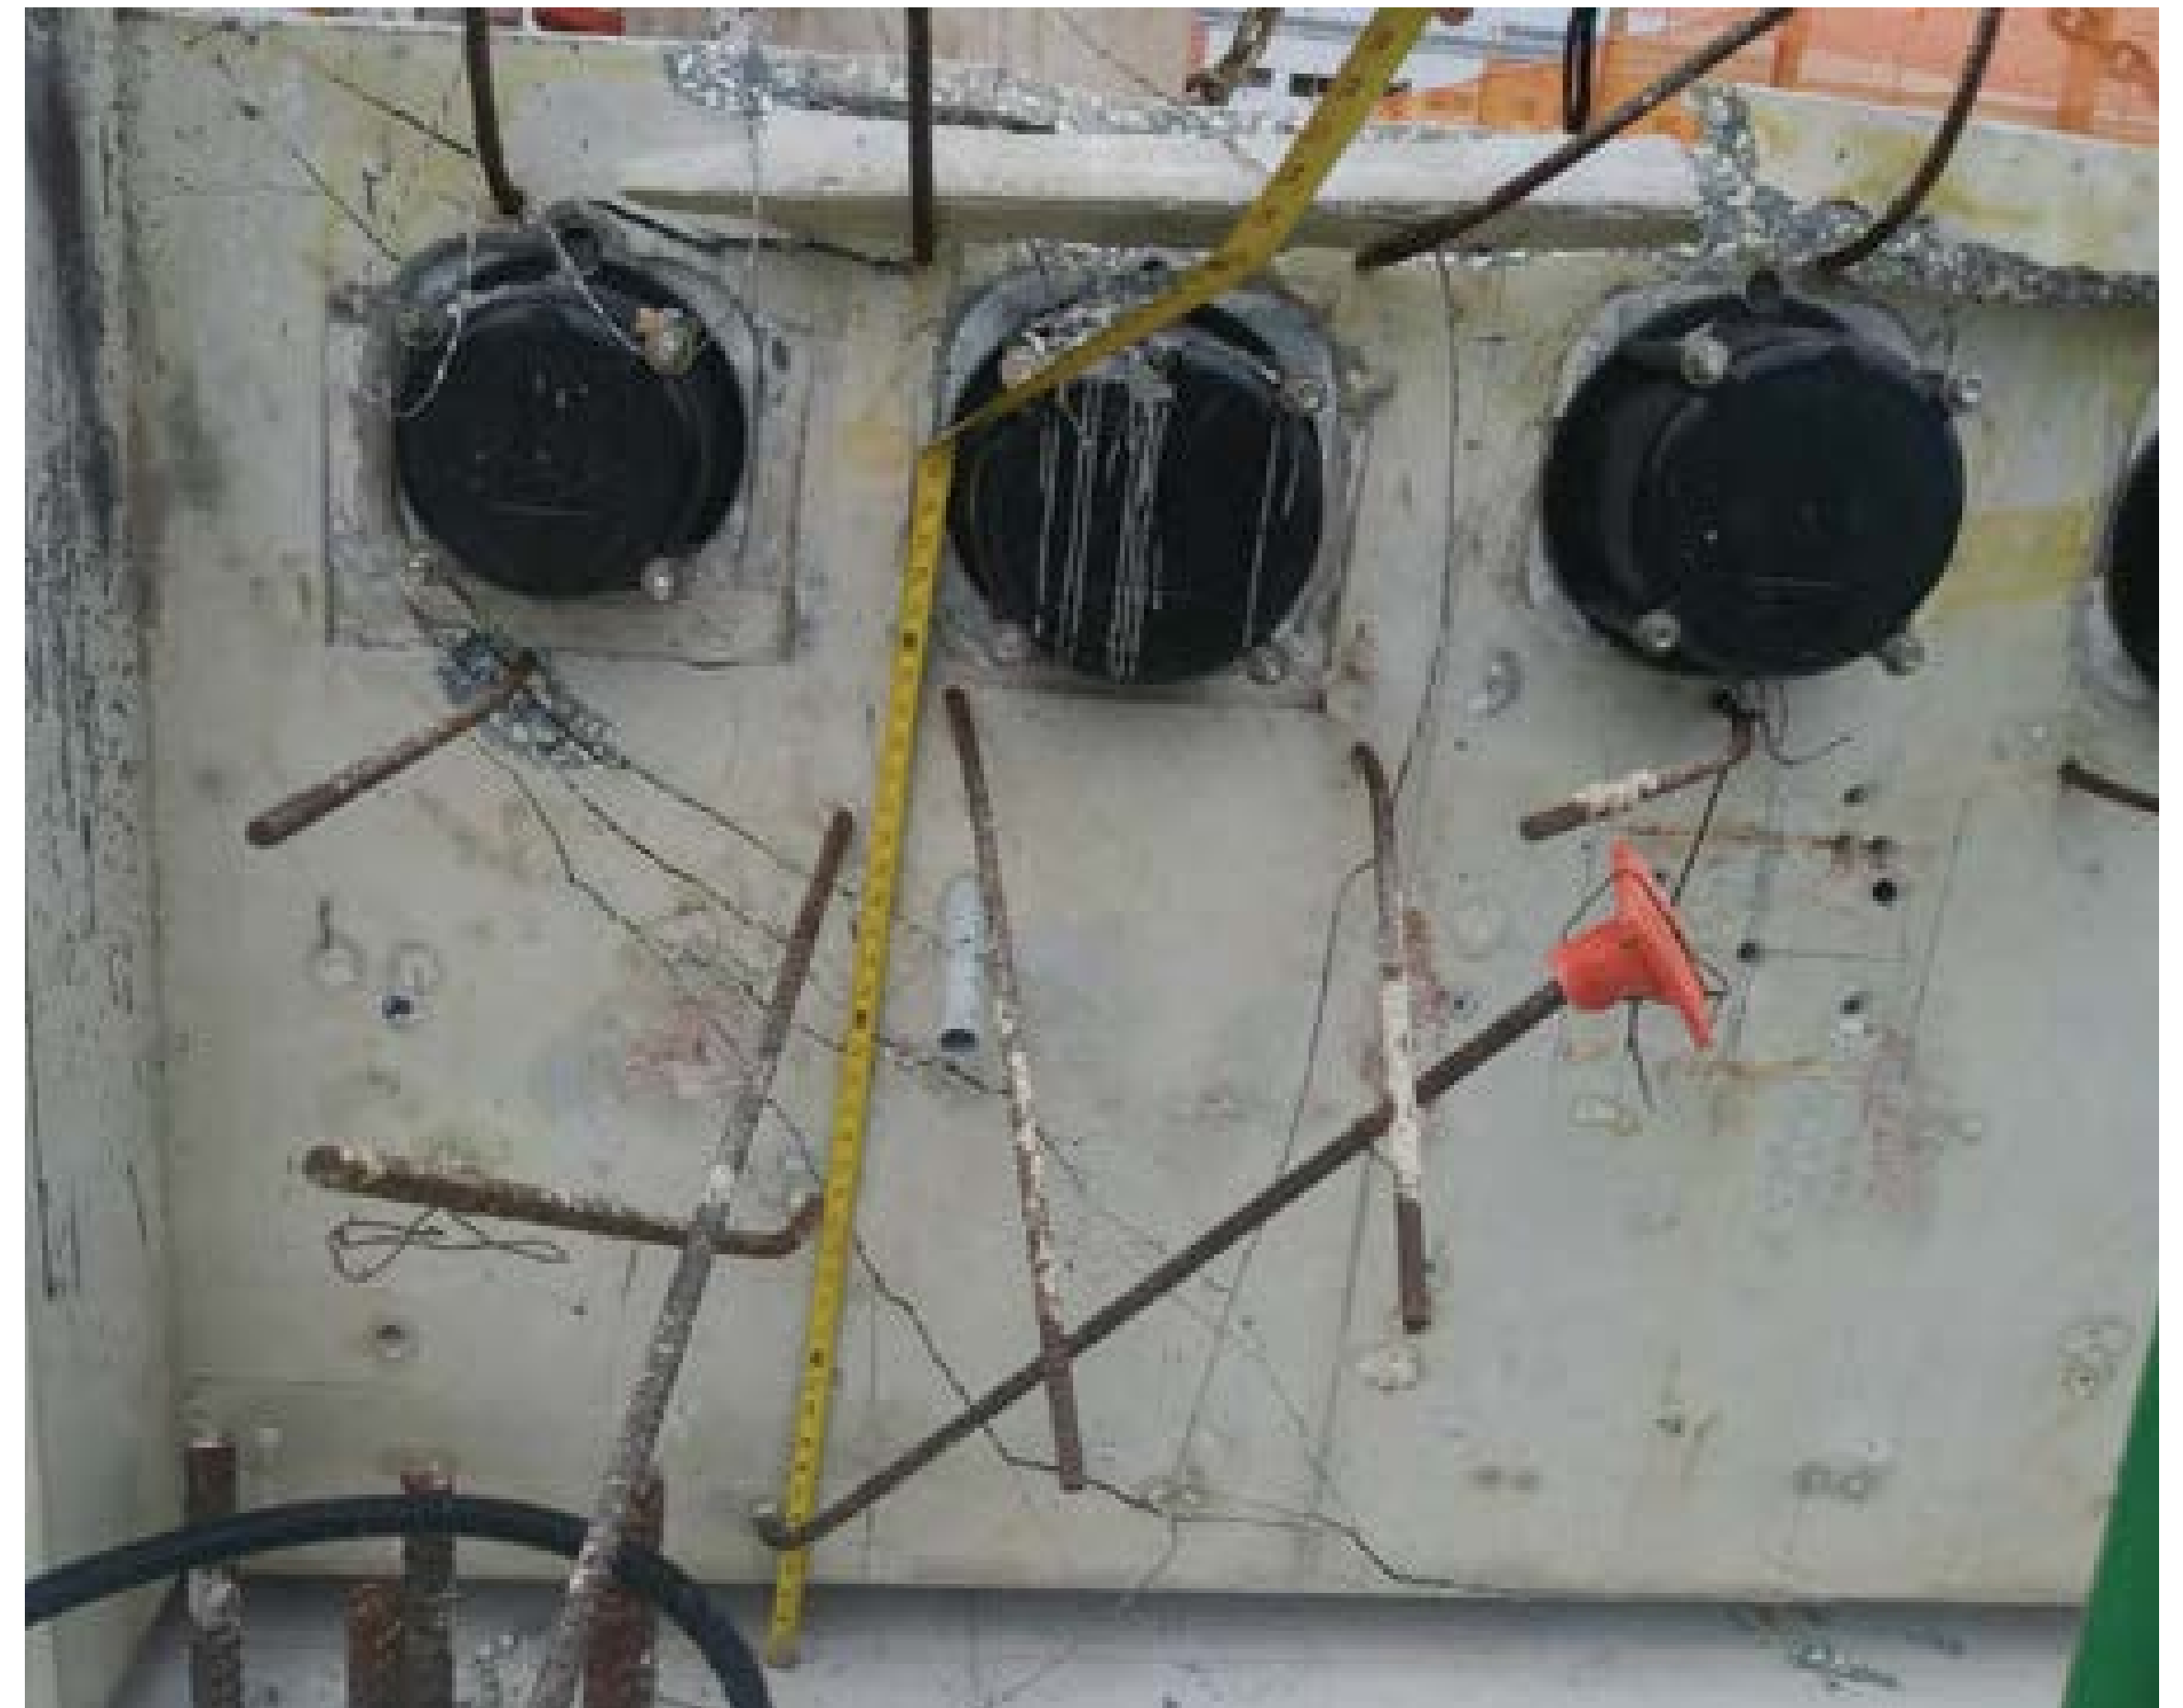
No information on cracking after bridge move on March 10 provided to FIGG until late on March 12 – pertained almost exclusively to the north diaphragm

FIGG was unaware that the construction joint had not been roughened or that the twist limit had been exceeded

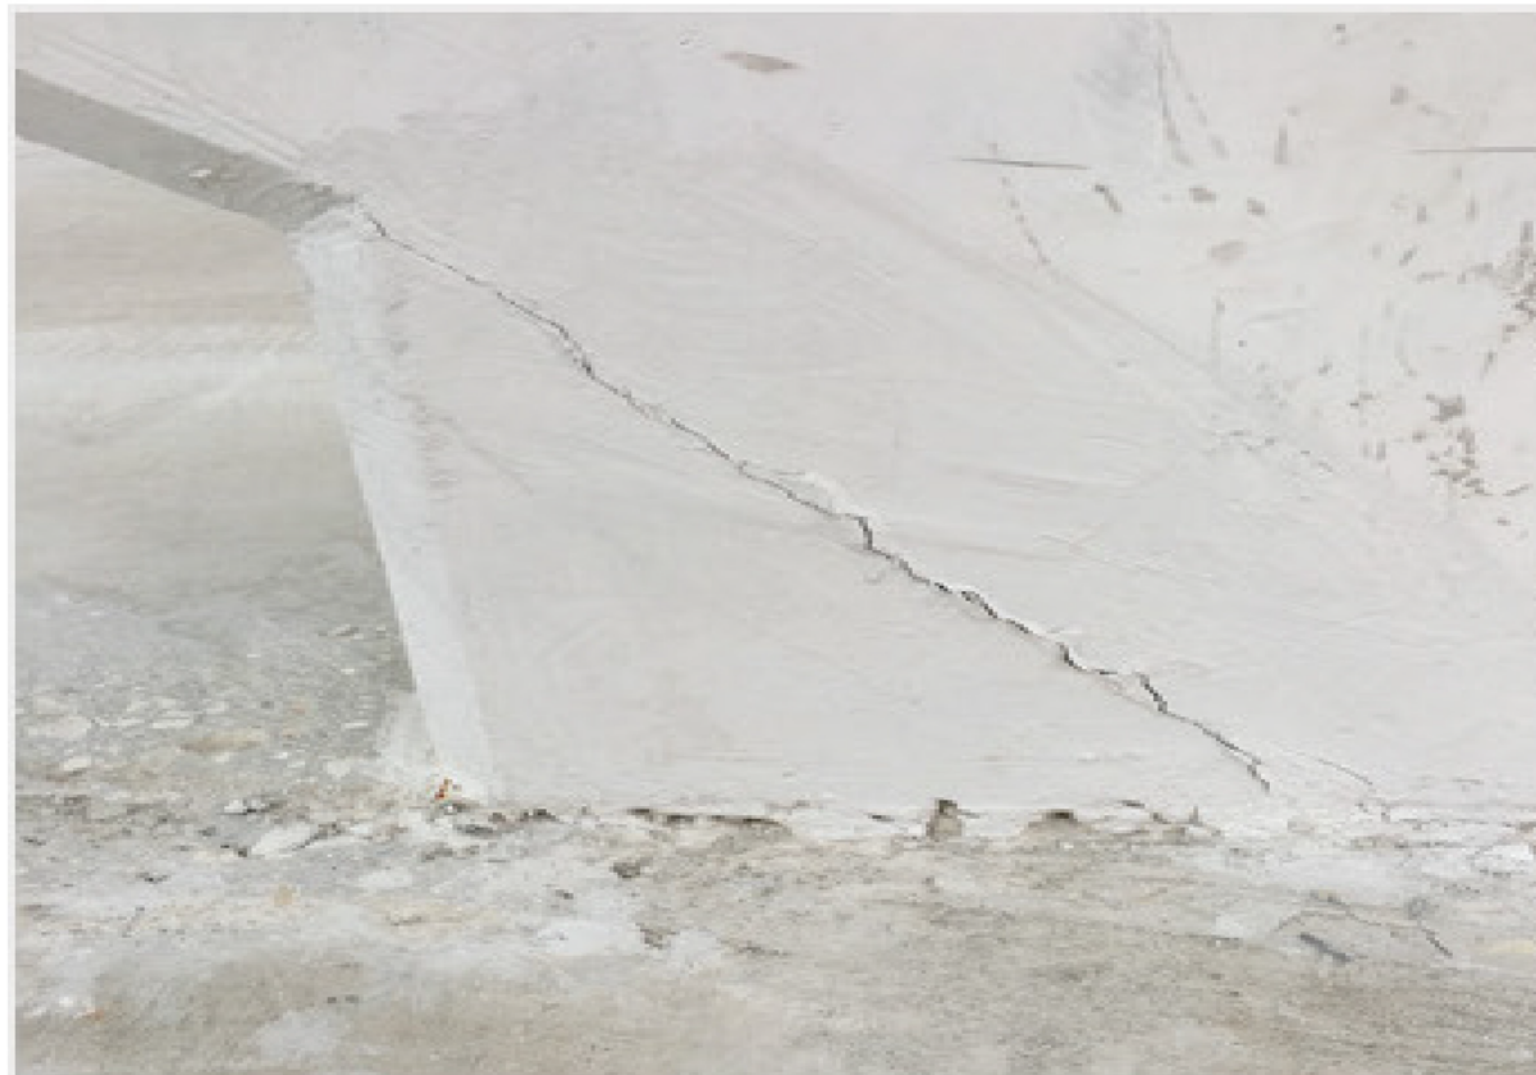
**SAT 3/10**

**Bridge move complete 12:30 pm**

**BPA finds significant change in cracking 3:00pm**

**Subcontractor text to coworker:  
"It cracked like hell" 7:08 pm**

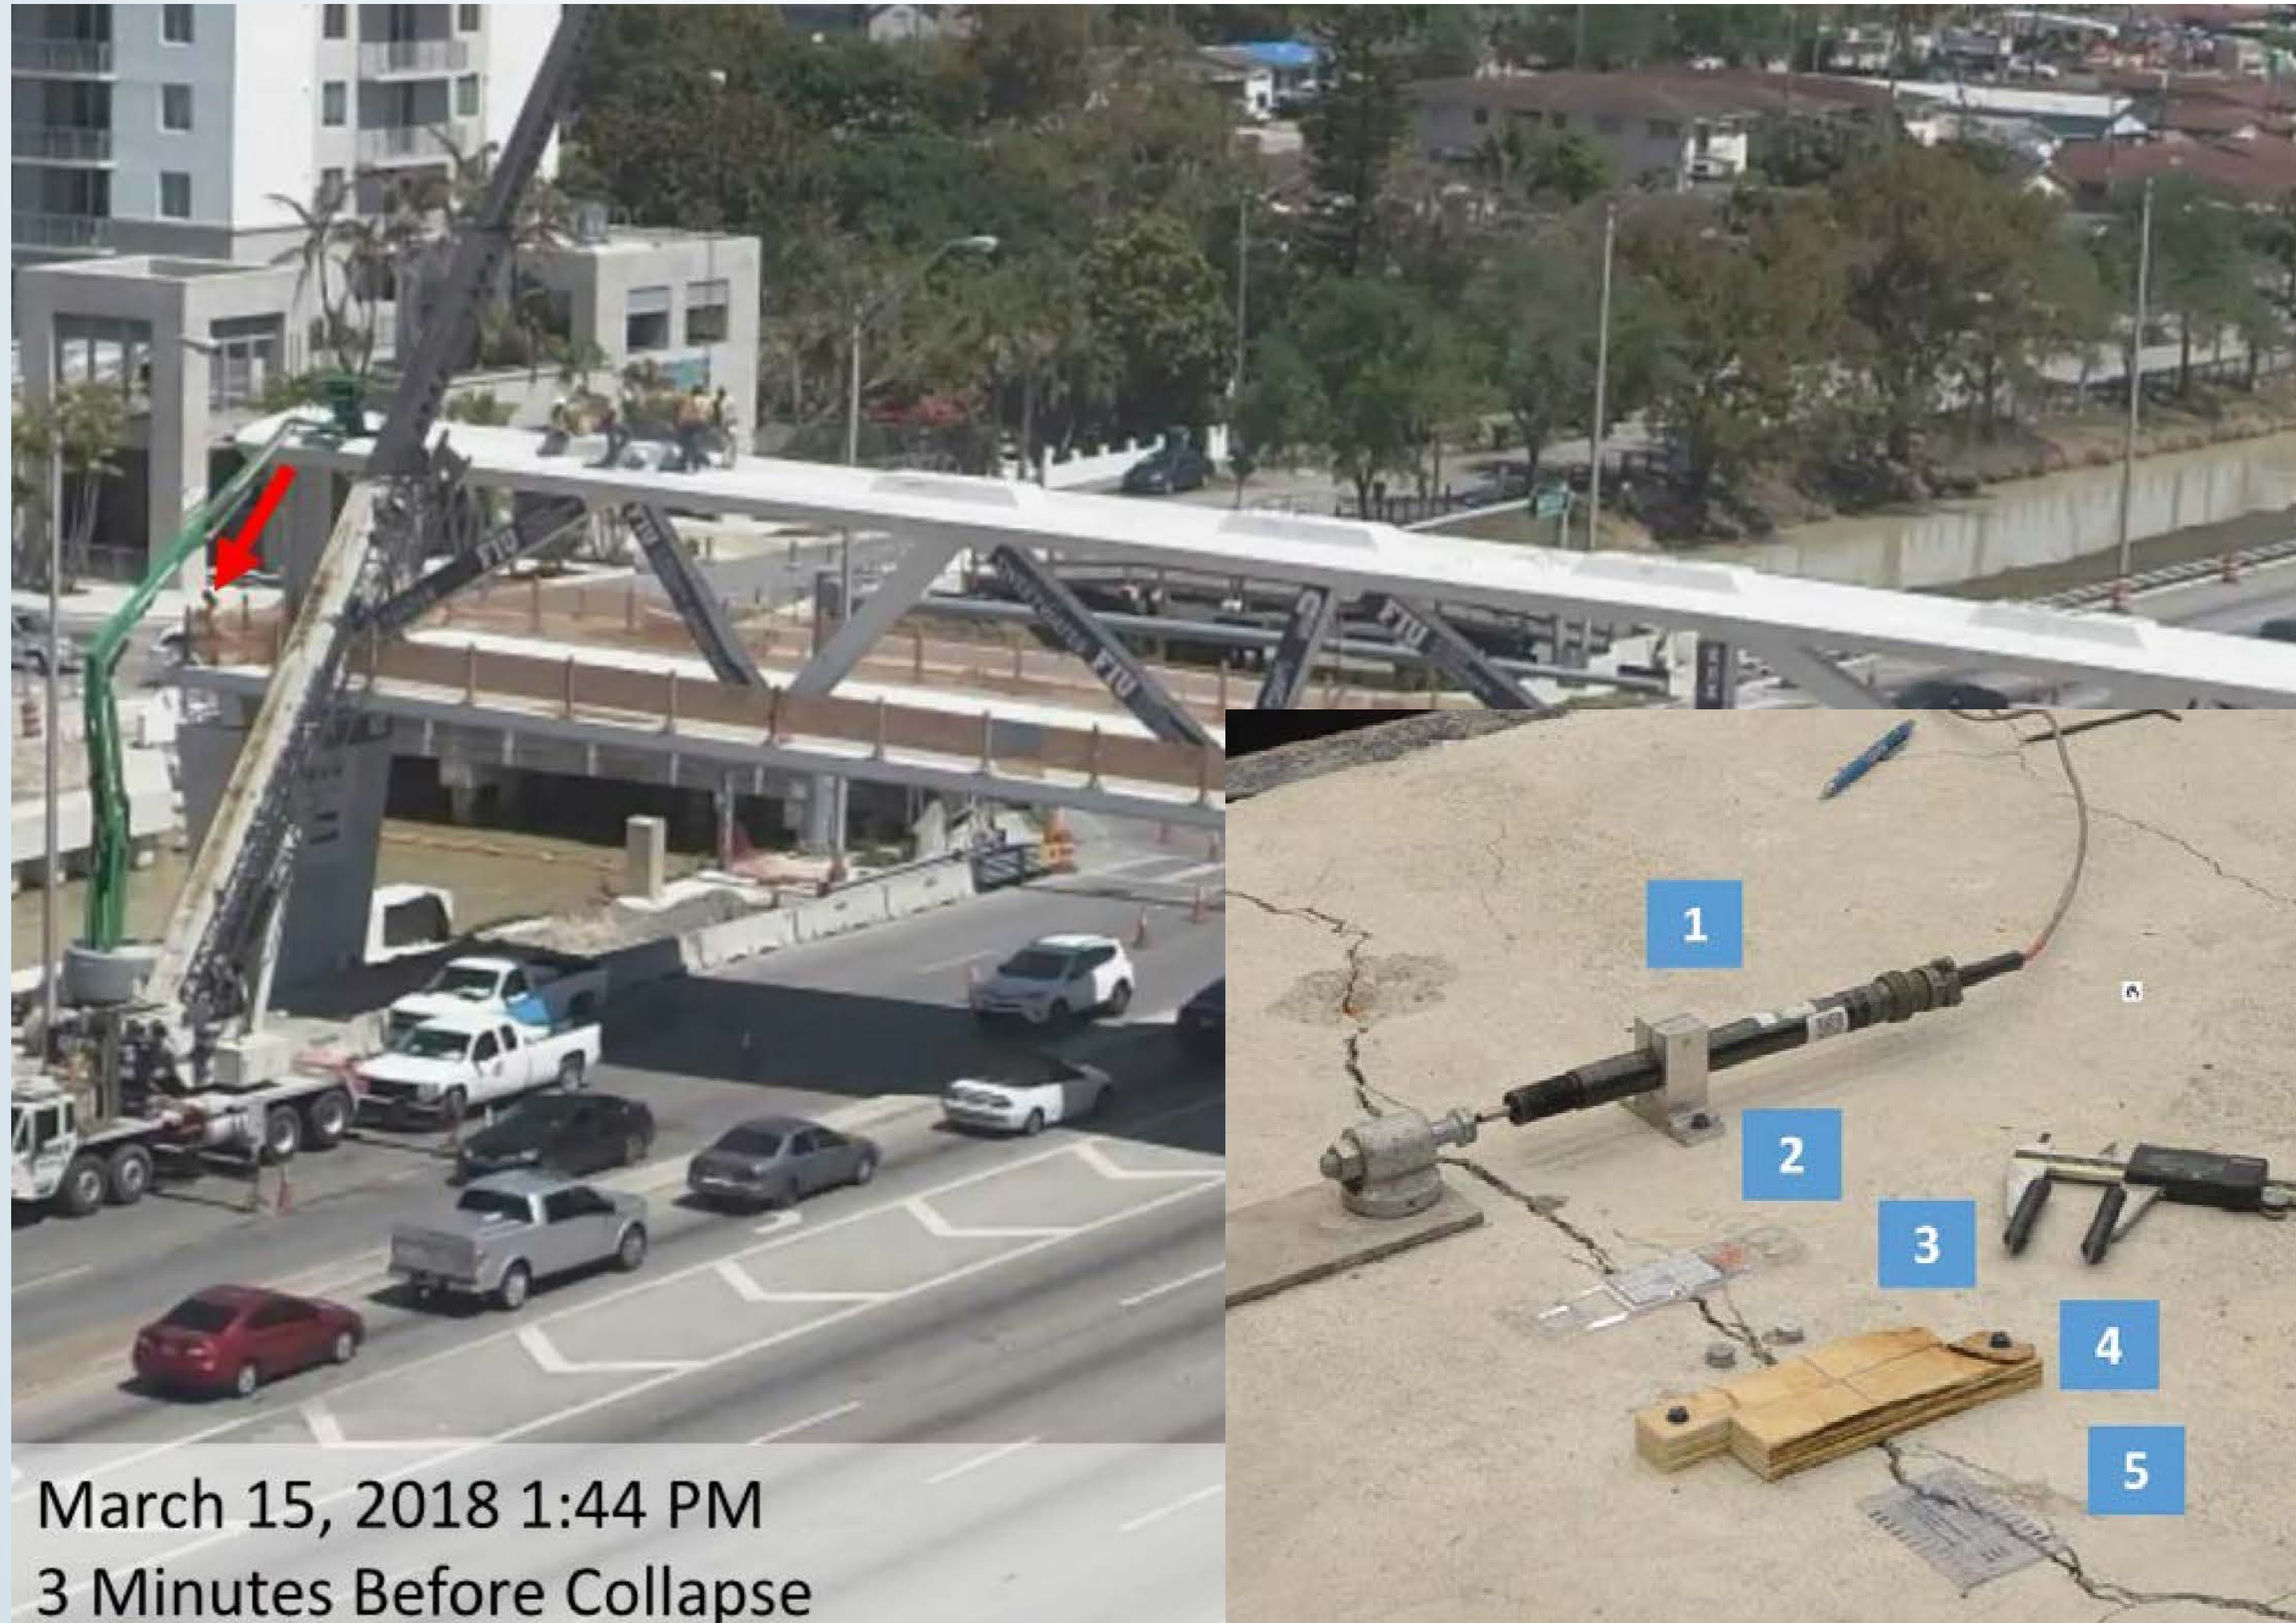
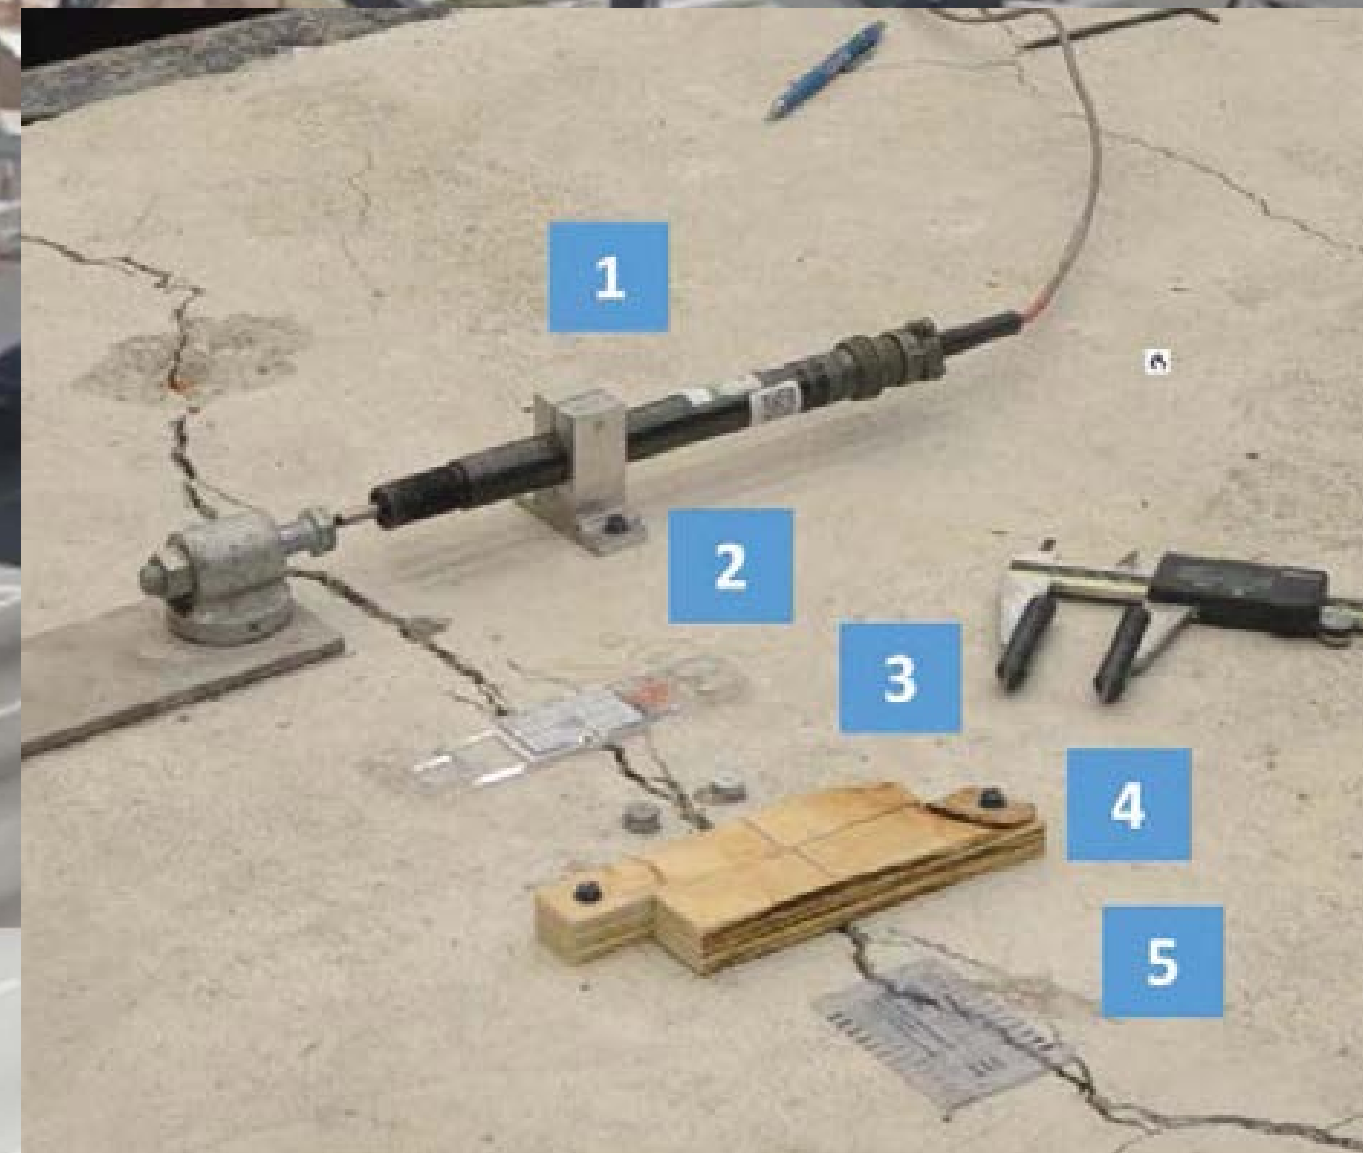
# Lack of Crack Monitoring during Re-Stressing

- *Contrary to FIGG instructions and Structural/VSL Safety Guidelines, no one closely monitored cracks in the north-end diaphragm during re-stressing of Member 11*
- *If closely monitored by MCM, Structural/VSL, BPA or Corradino, increases in crack width could have been readily detected by several means, including use of wood block crack gauges, which were already used at the site.*

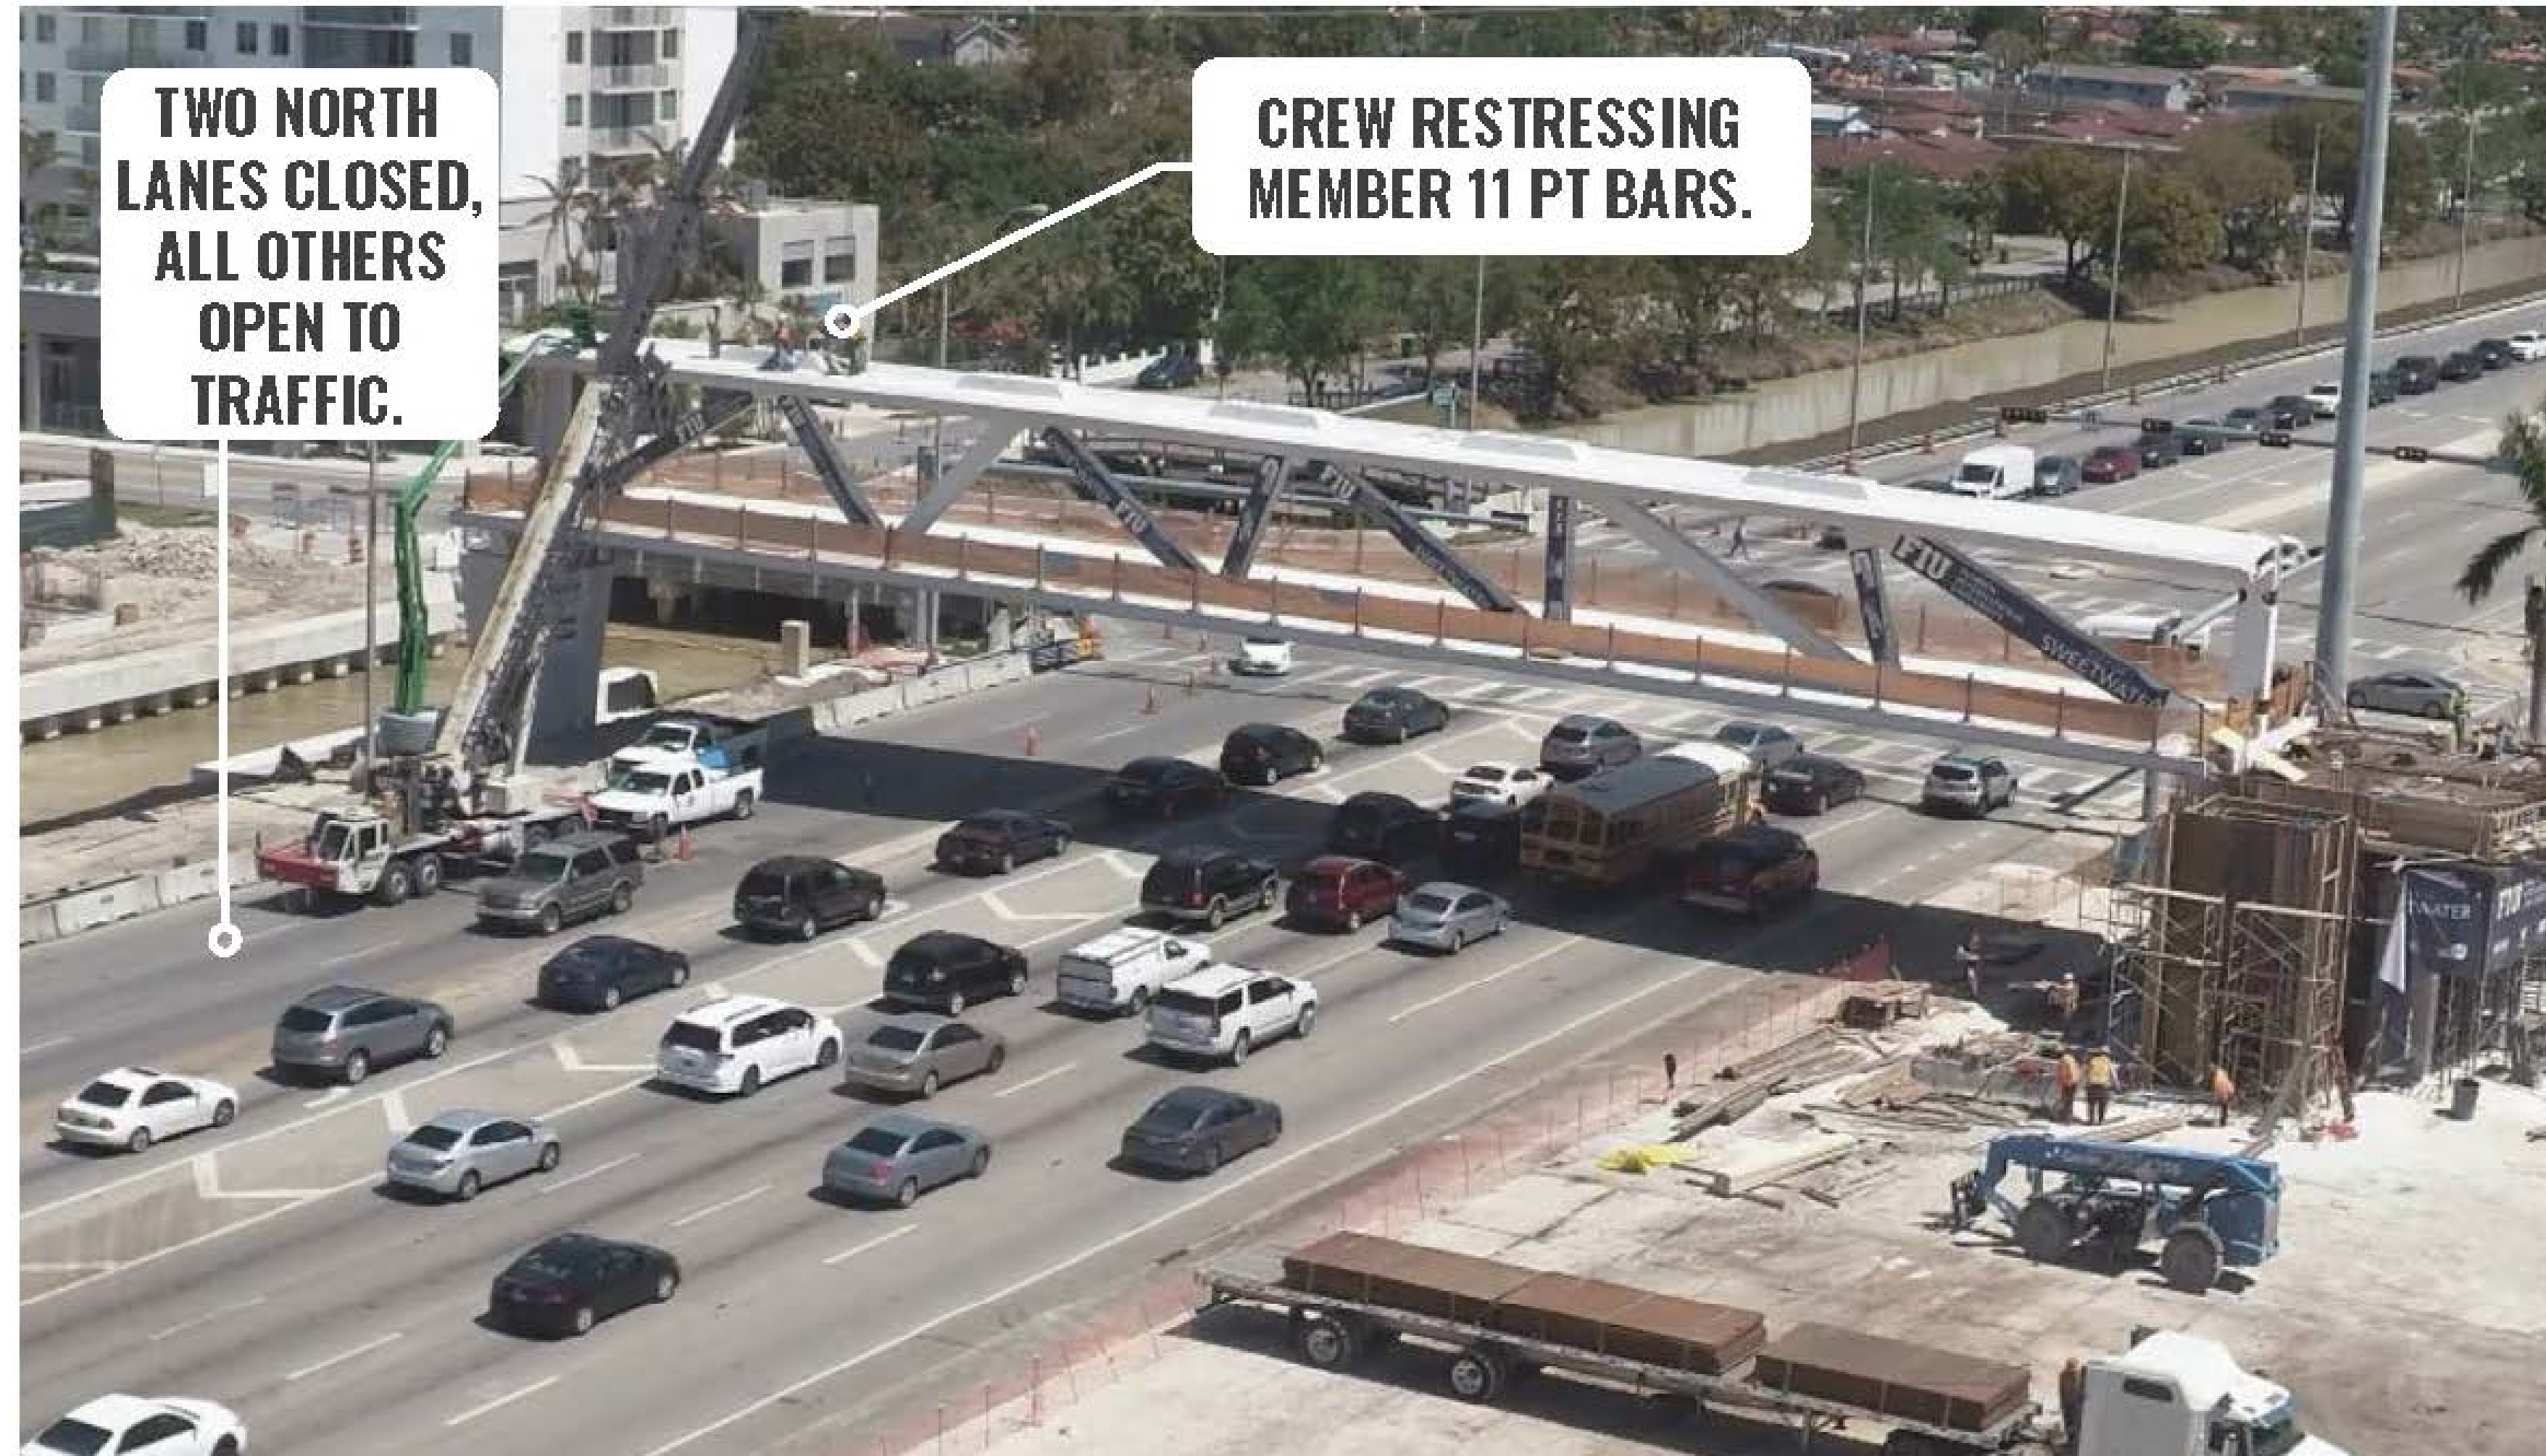
No one at the March 15 meeting the morning of the accident suggested closing SW 8<sup>th</sup> Street.

Subcontractor restressing PT bars in Member #11 only defined the work zone as the north two lanes.

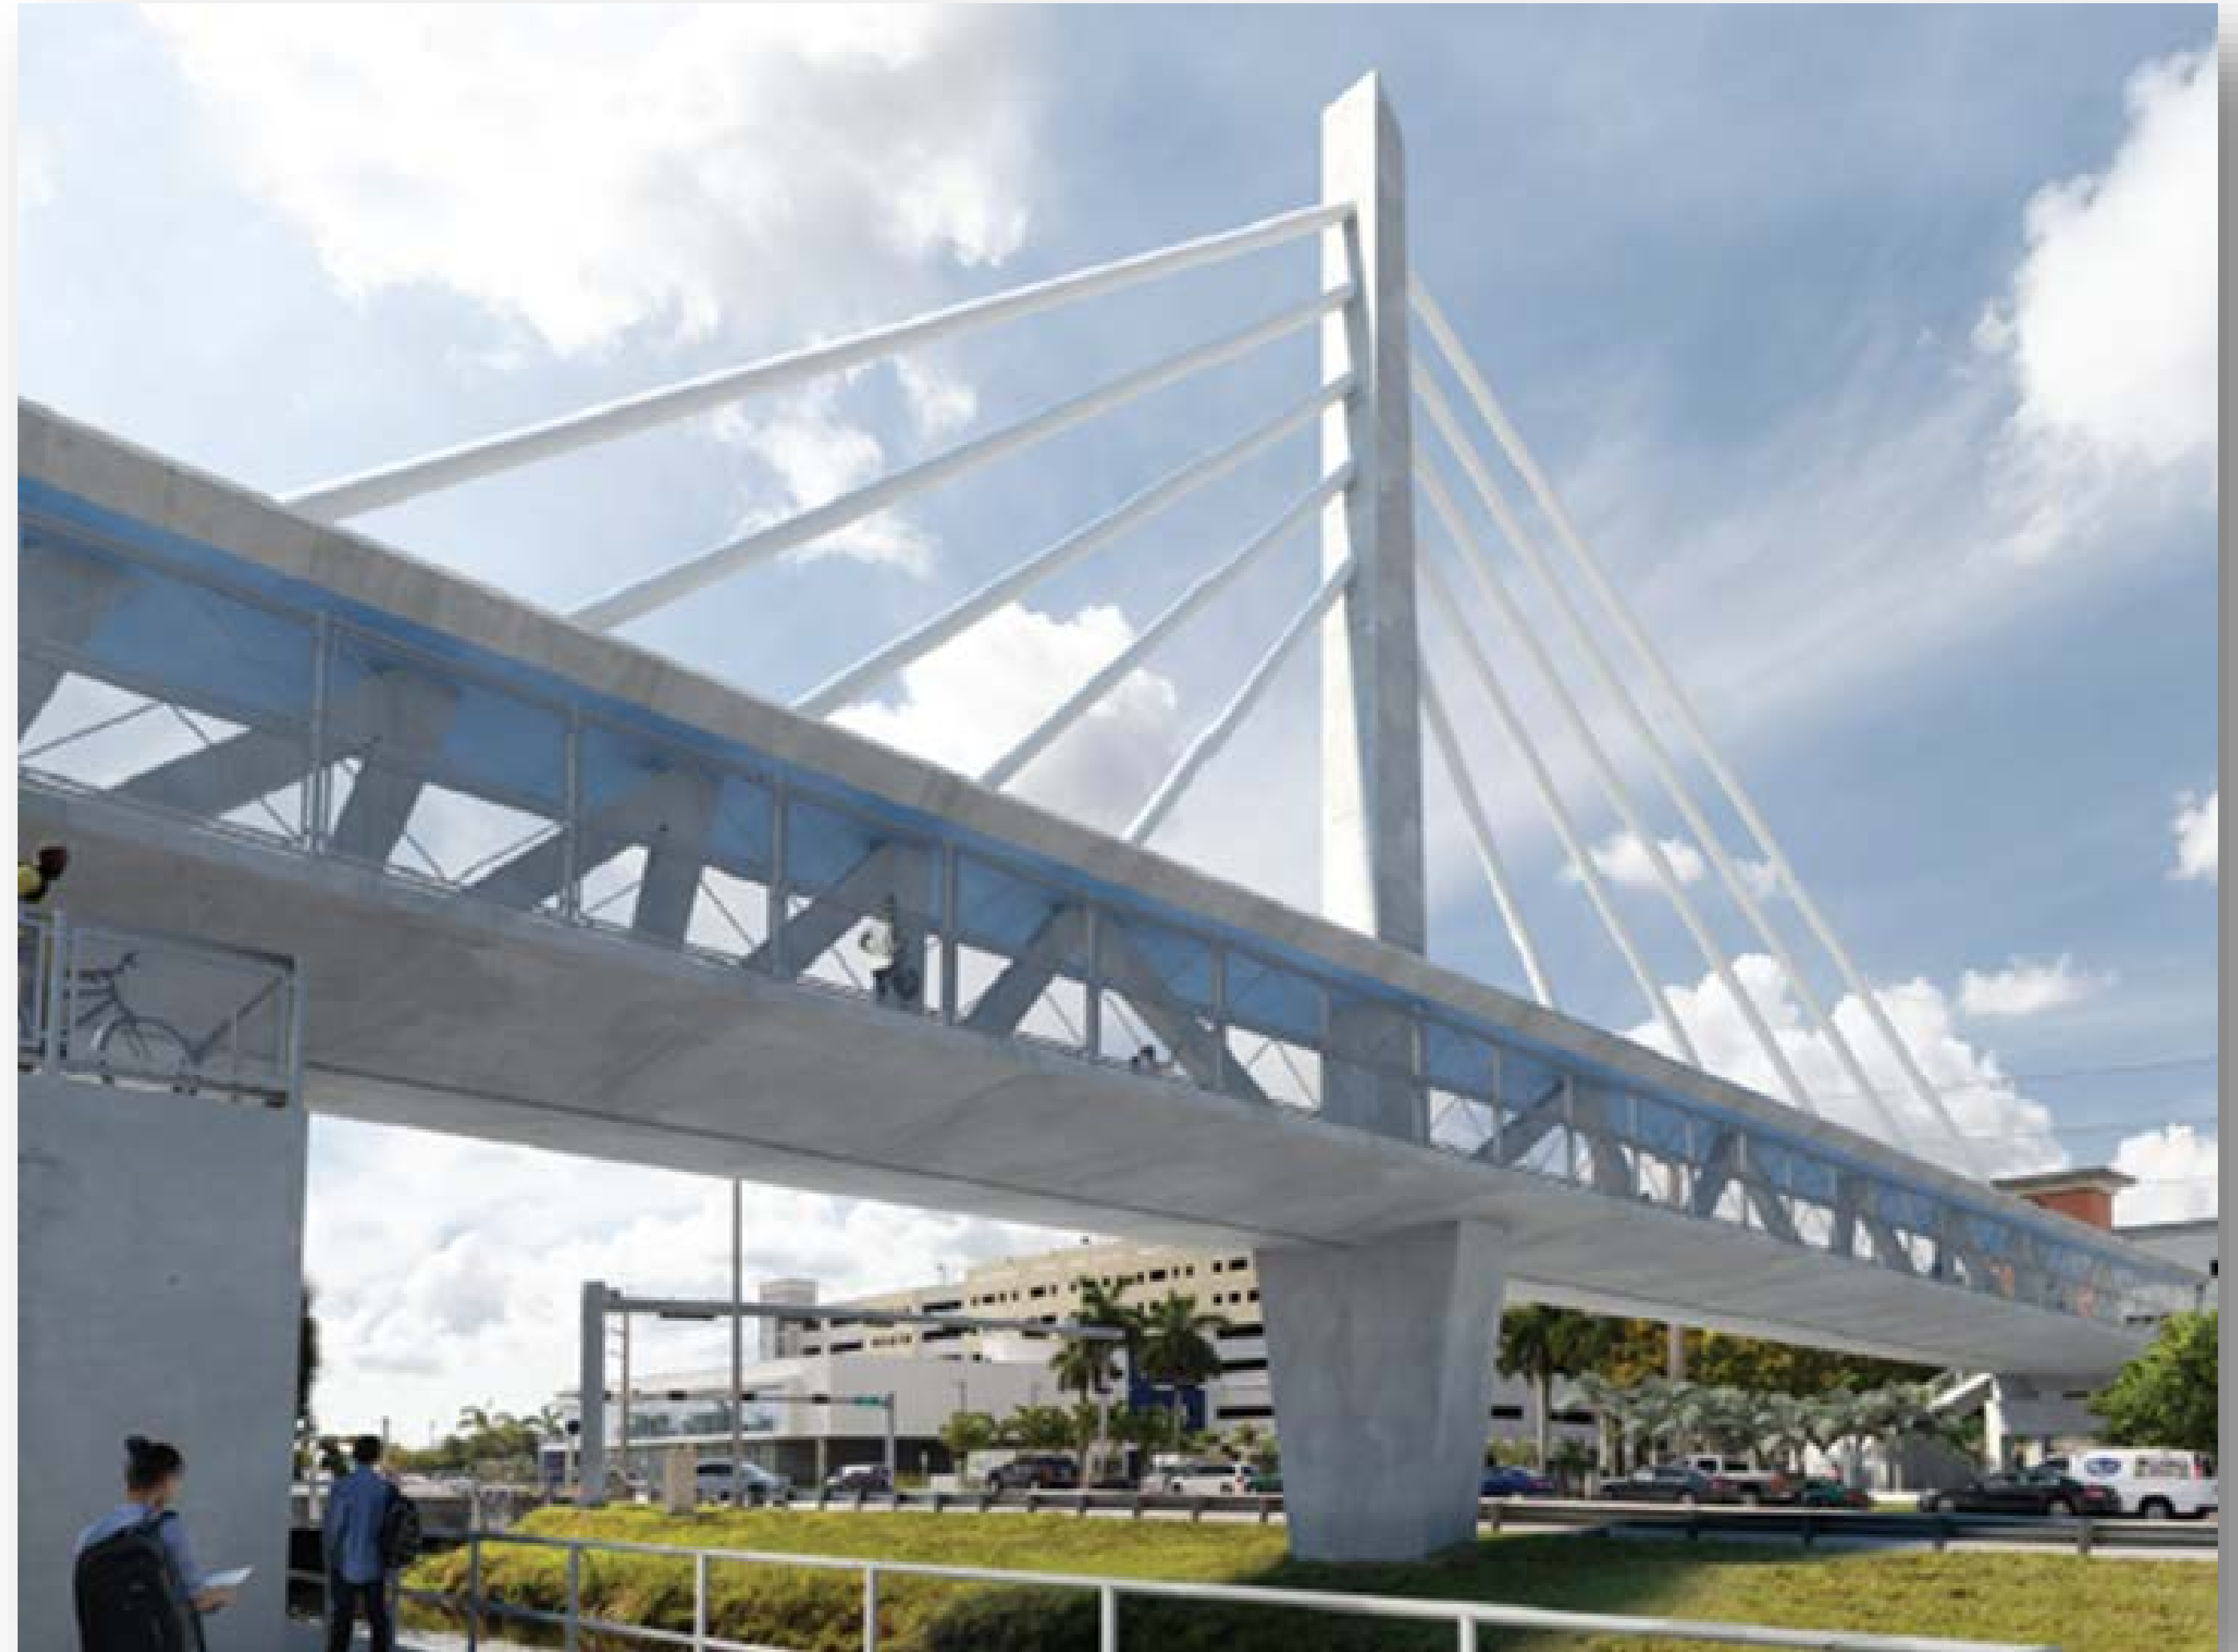
***Testing of Full-Size  
Replicas of Failed  
Connection***
