# FIU PEDESTRIAN BRIDGE COLLAPSE

## AASHTO Committee on Construction VIRTUAL ANNUAL MEETING

Gary J. Klein, P.E., S.E. – Wiss, Janney, Elstner Associates, Inc.

August 13, 2020

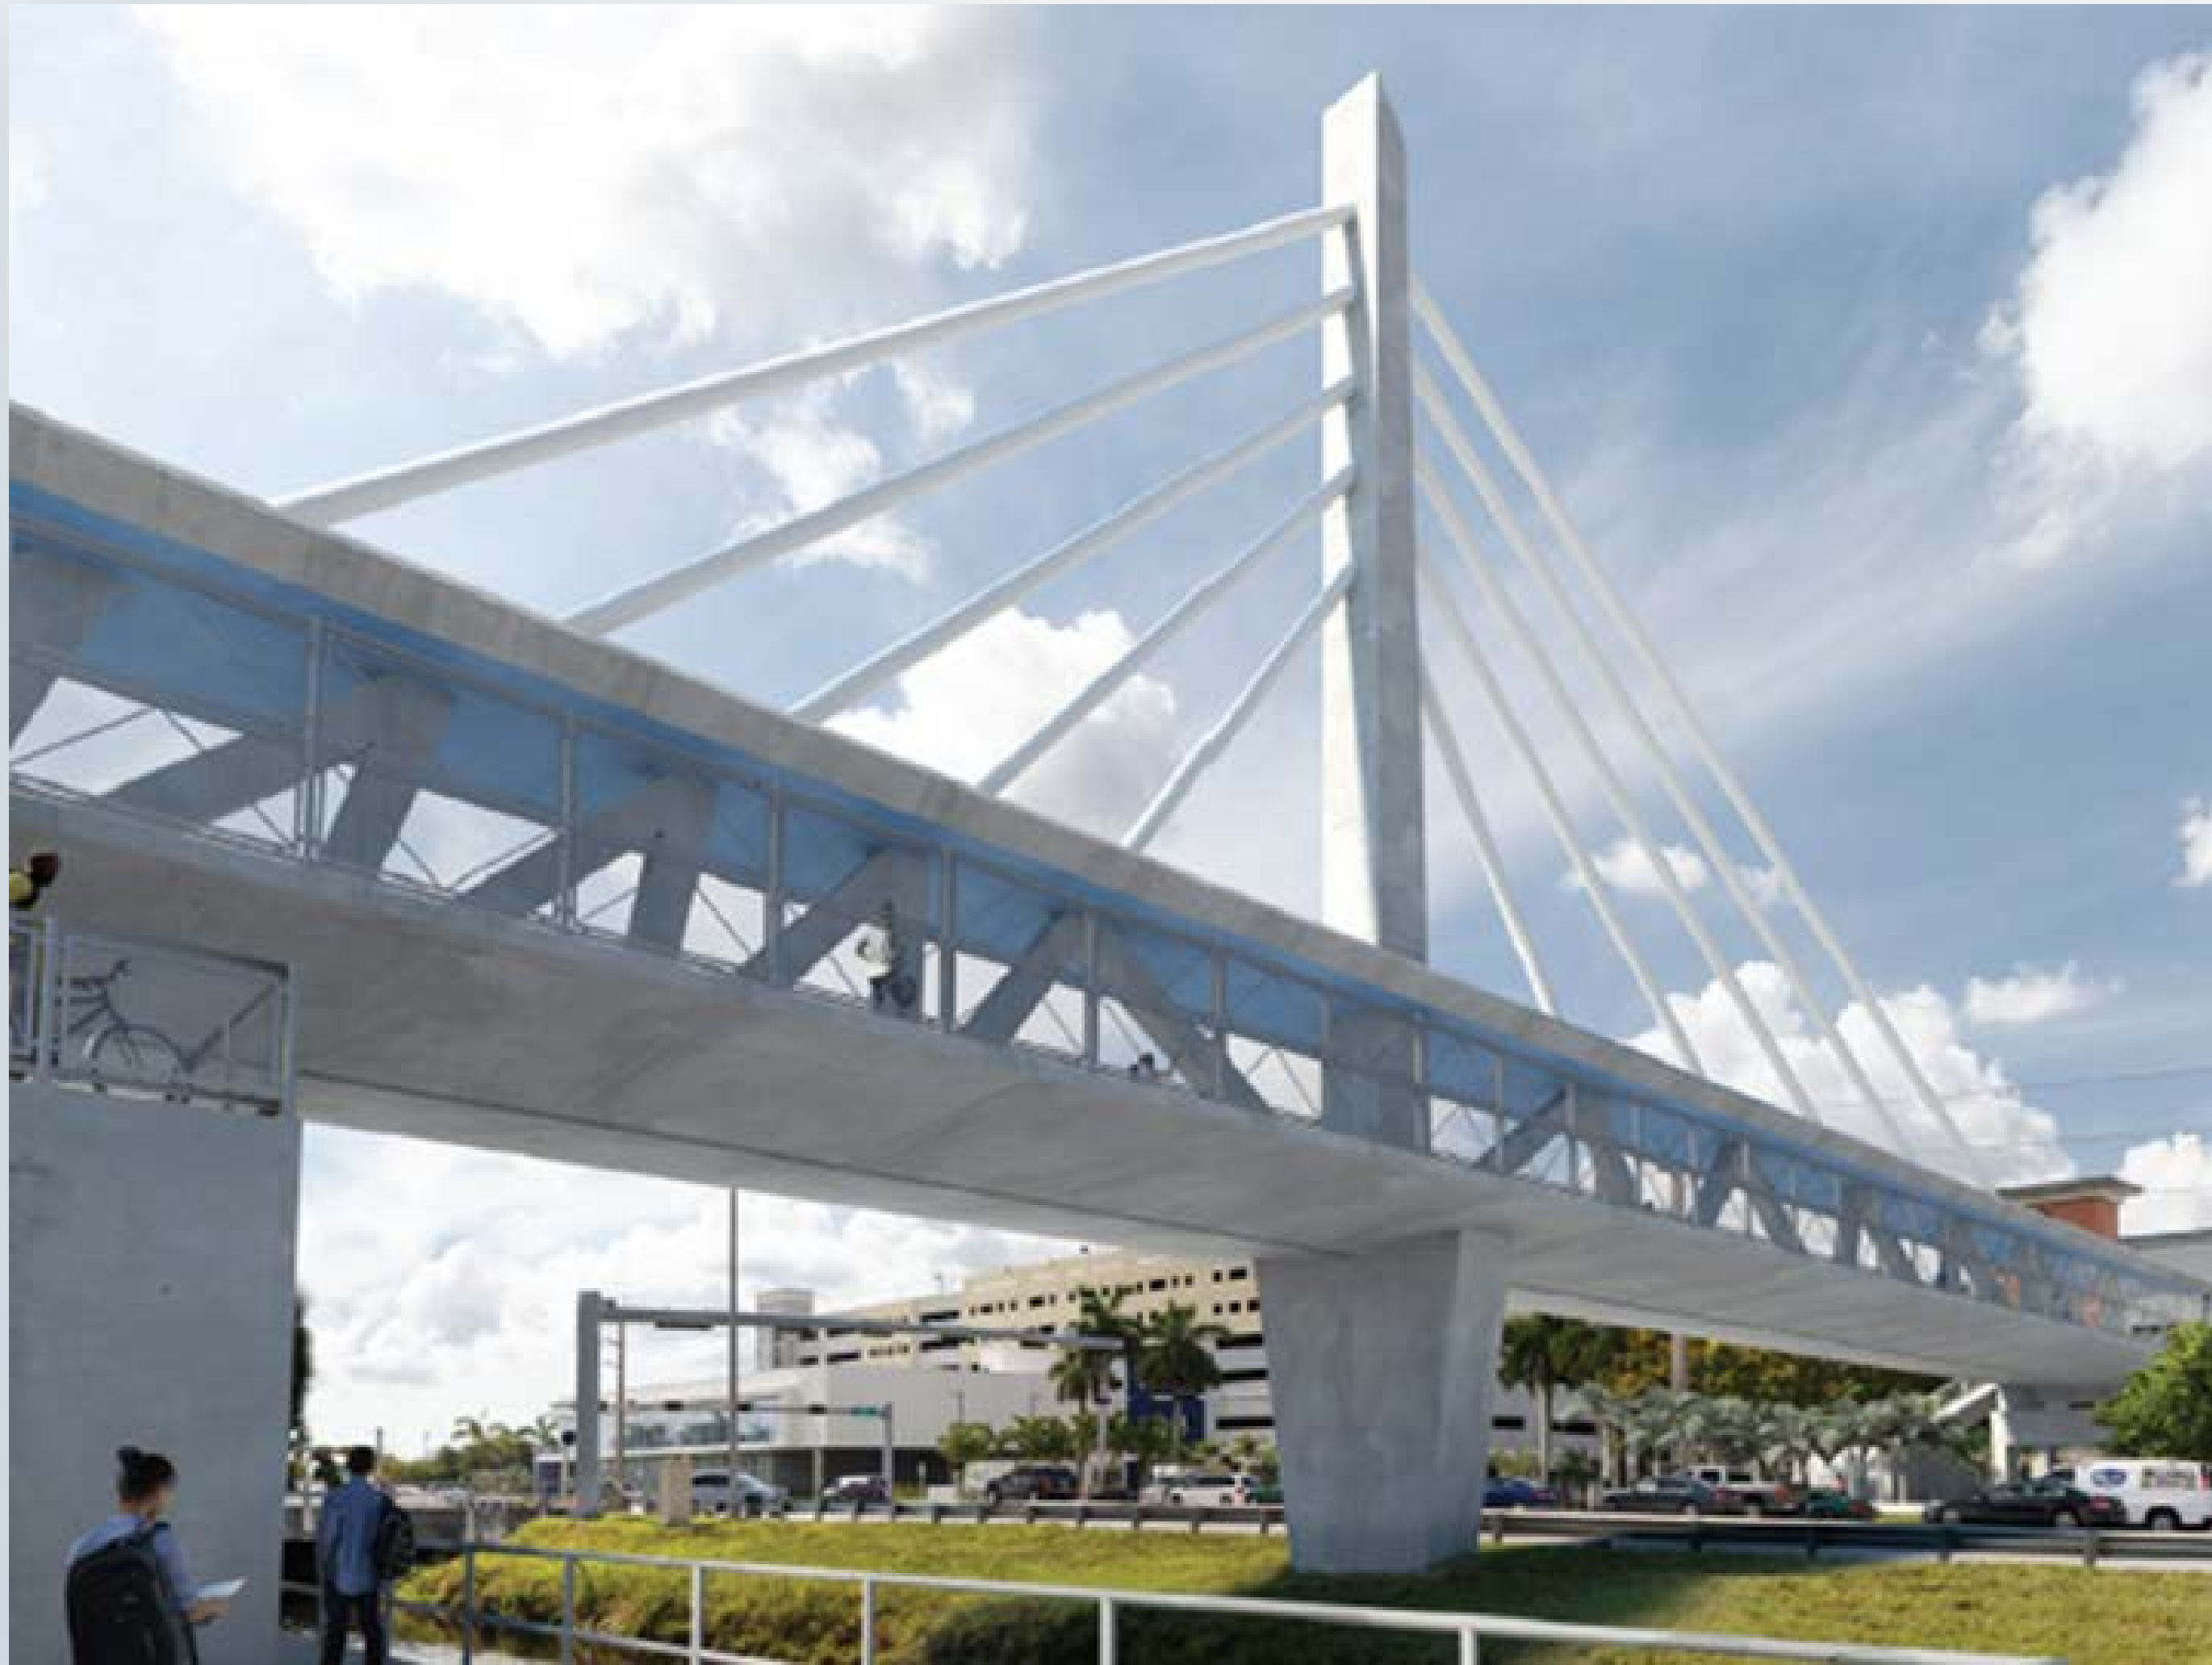
## Bridge Description

- Two-span truss; 175 foot main span
- Pylon and stay cables (actually pipes) are architectural features
- Canopy and 32-foot wide deck are post-tensioned
- Most diagonals are posttensioned

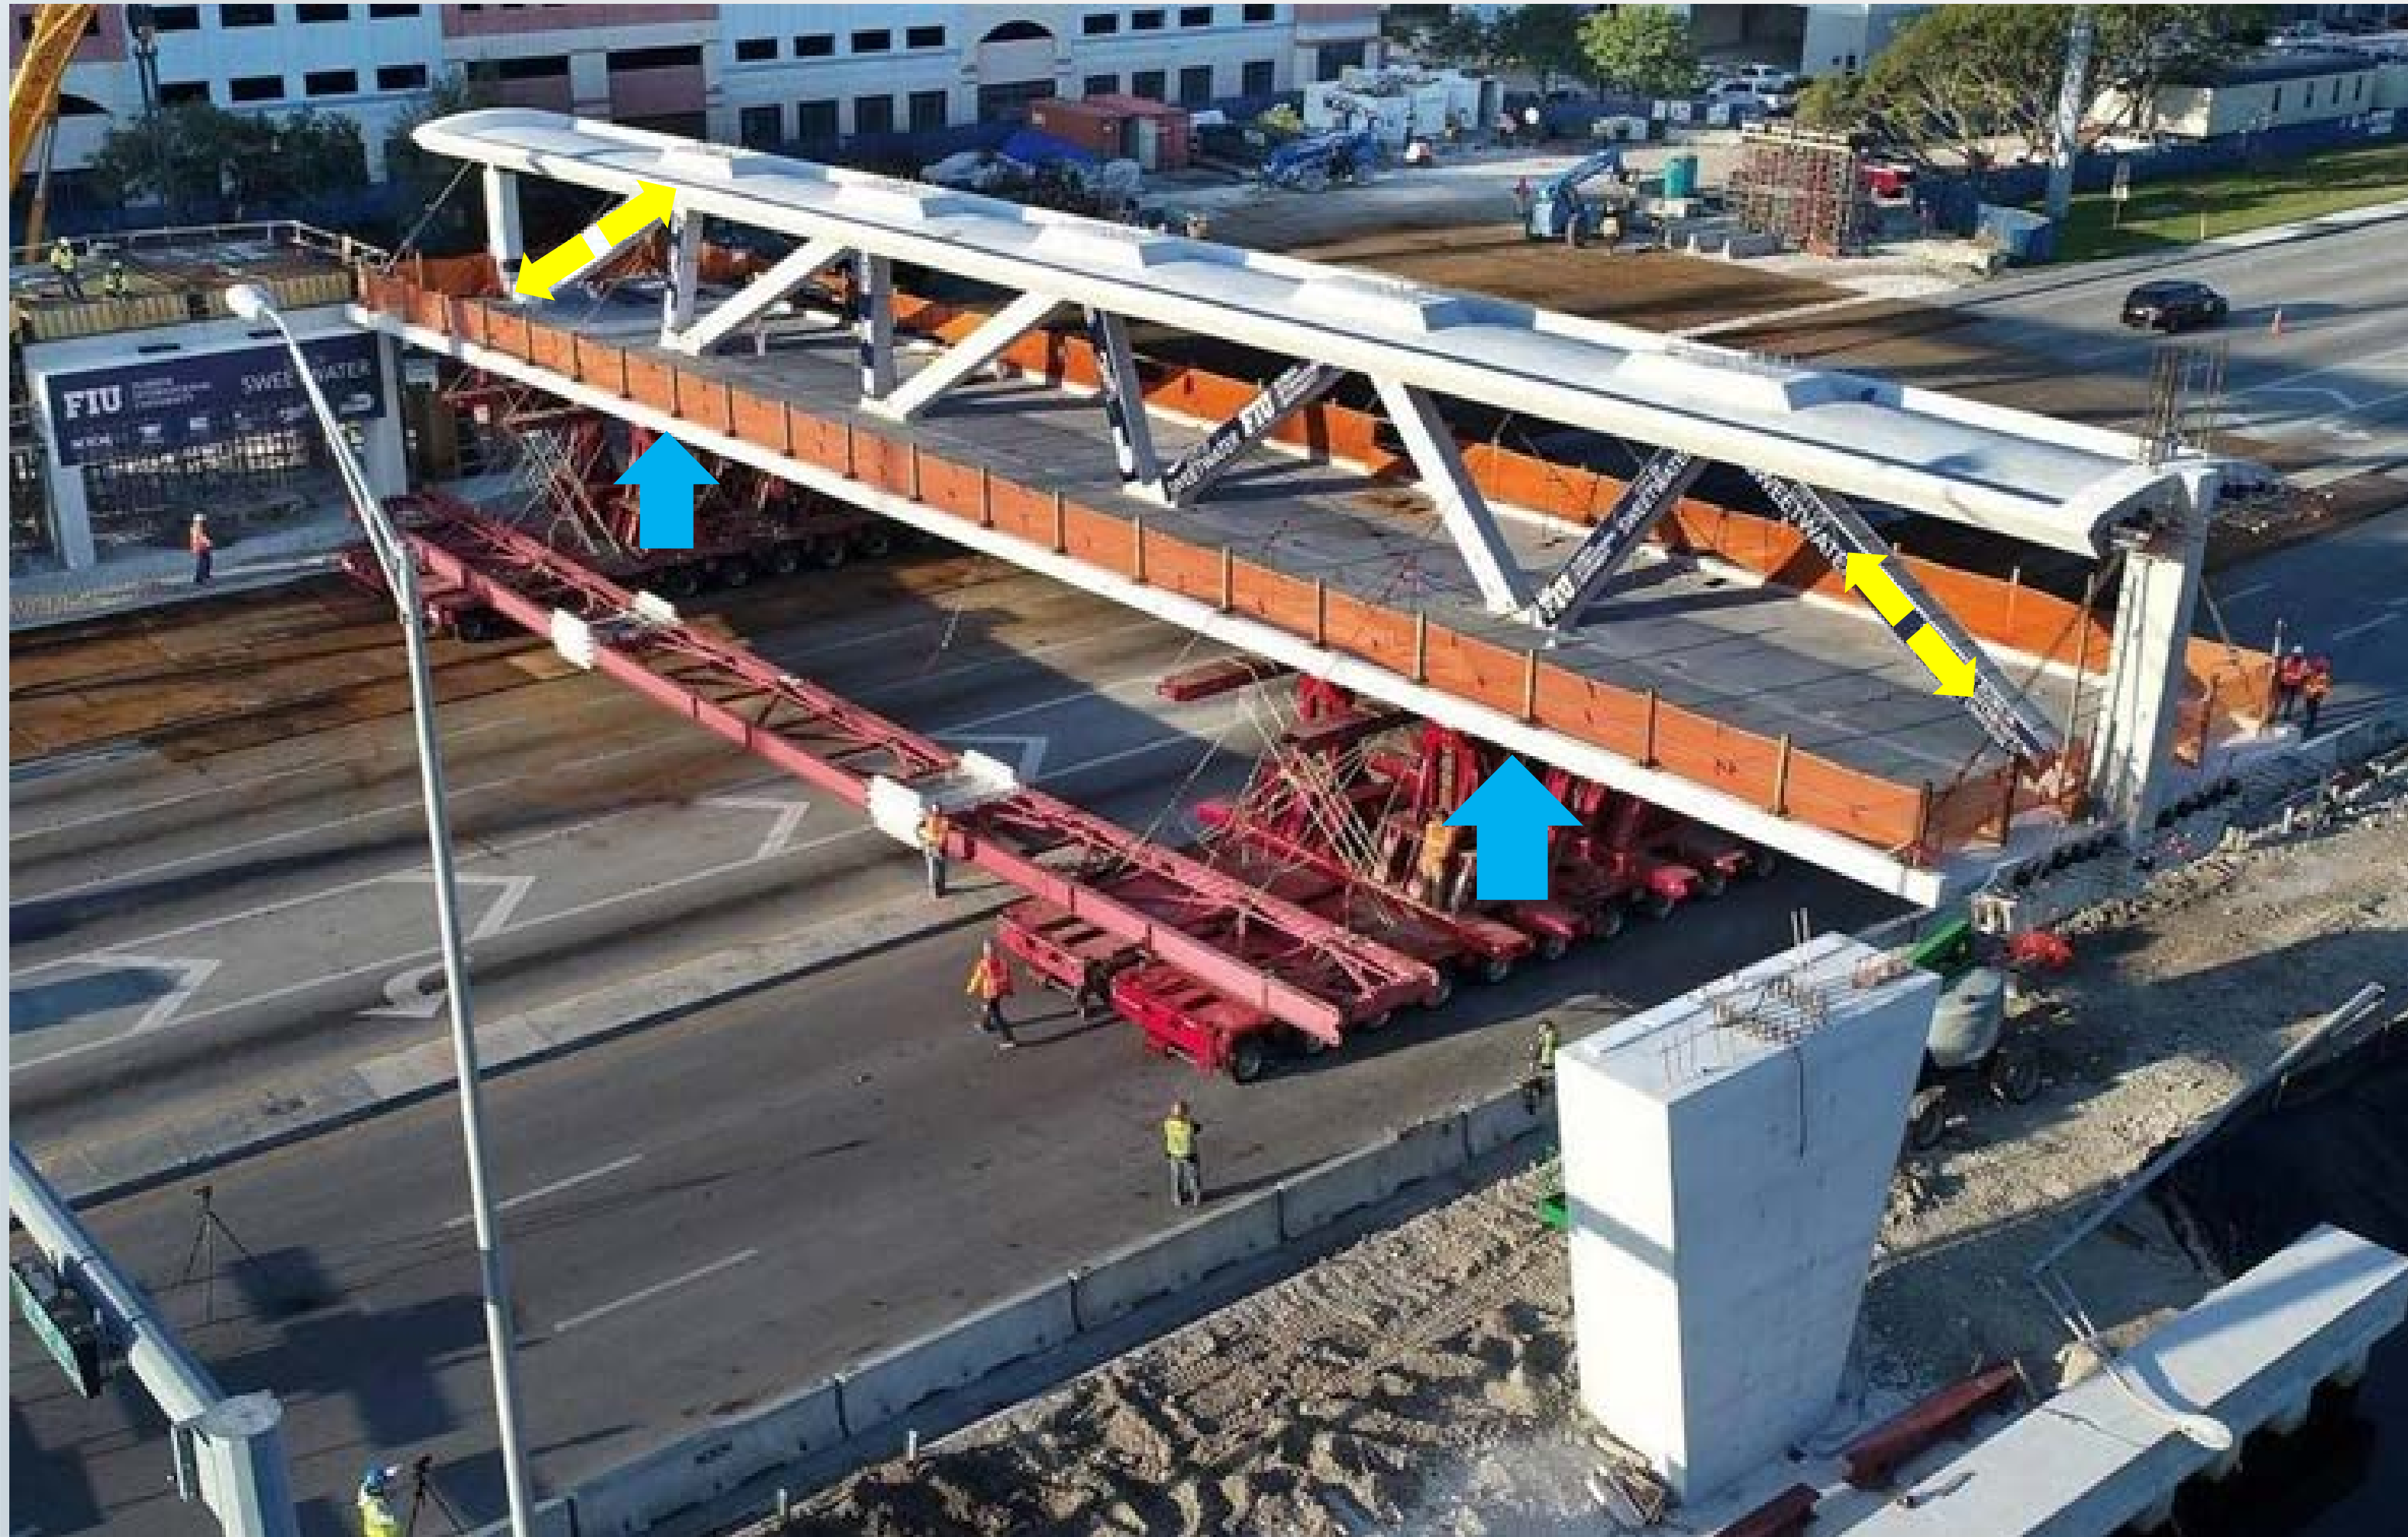
*Move of Main Span into Position: March 10, 2018*

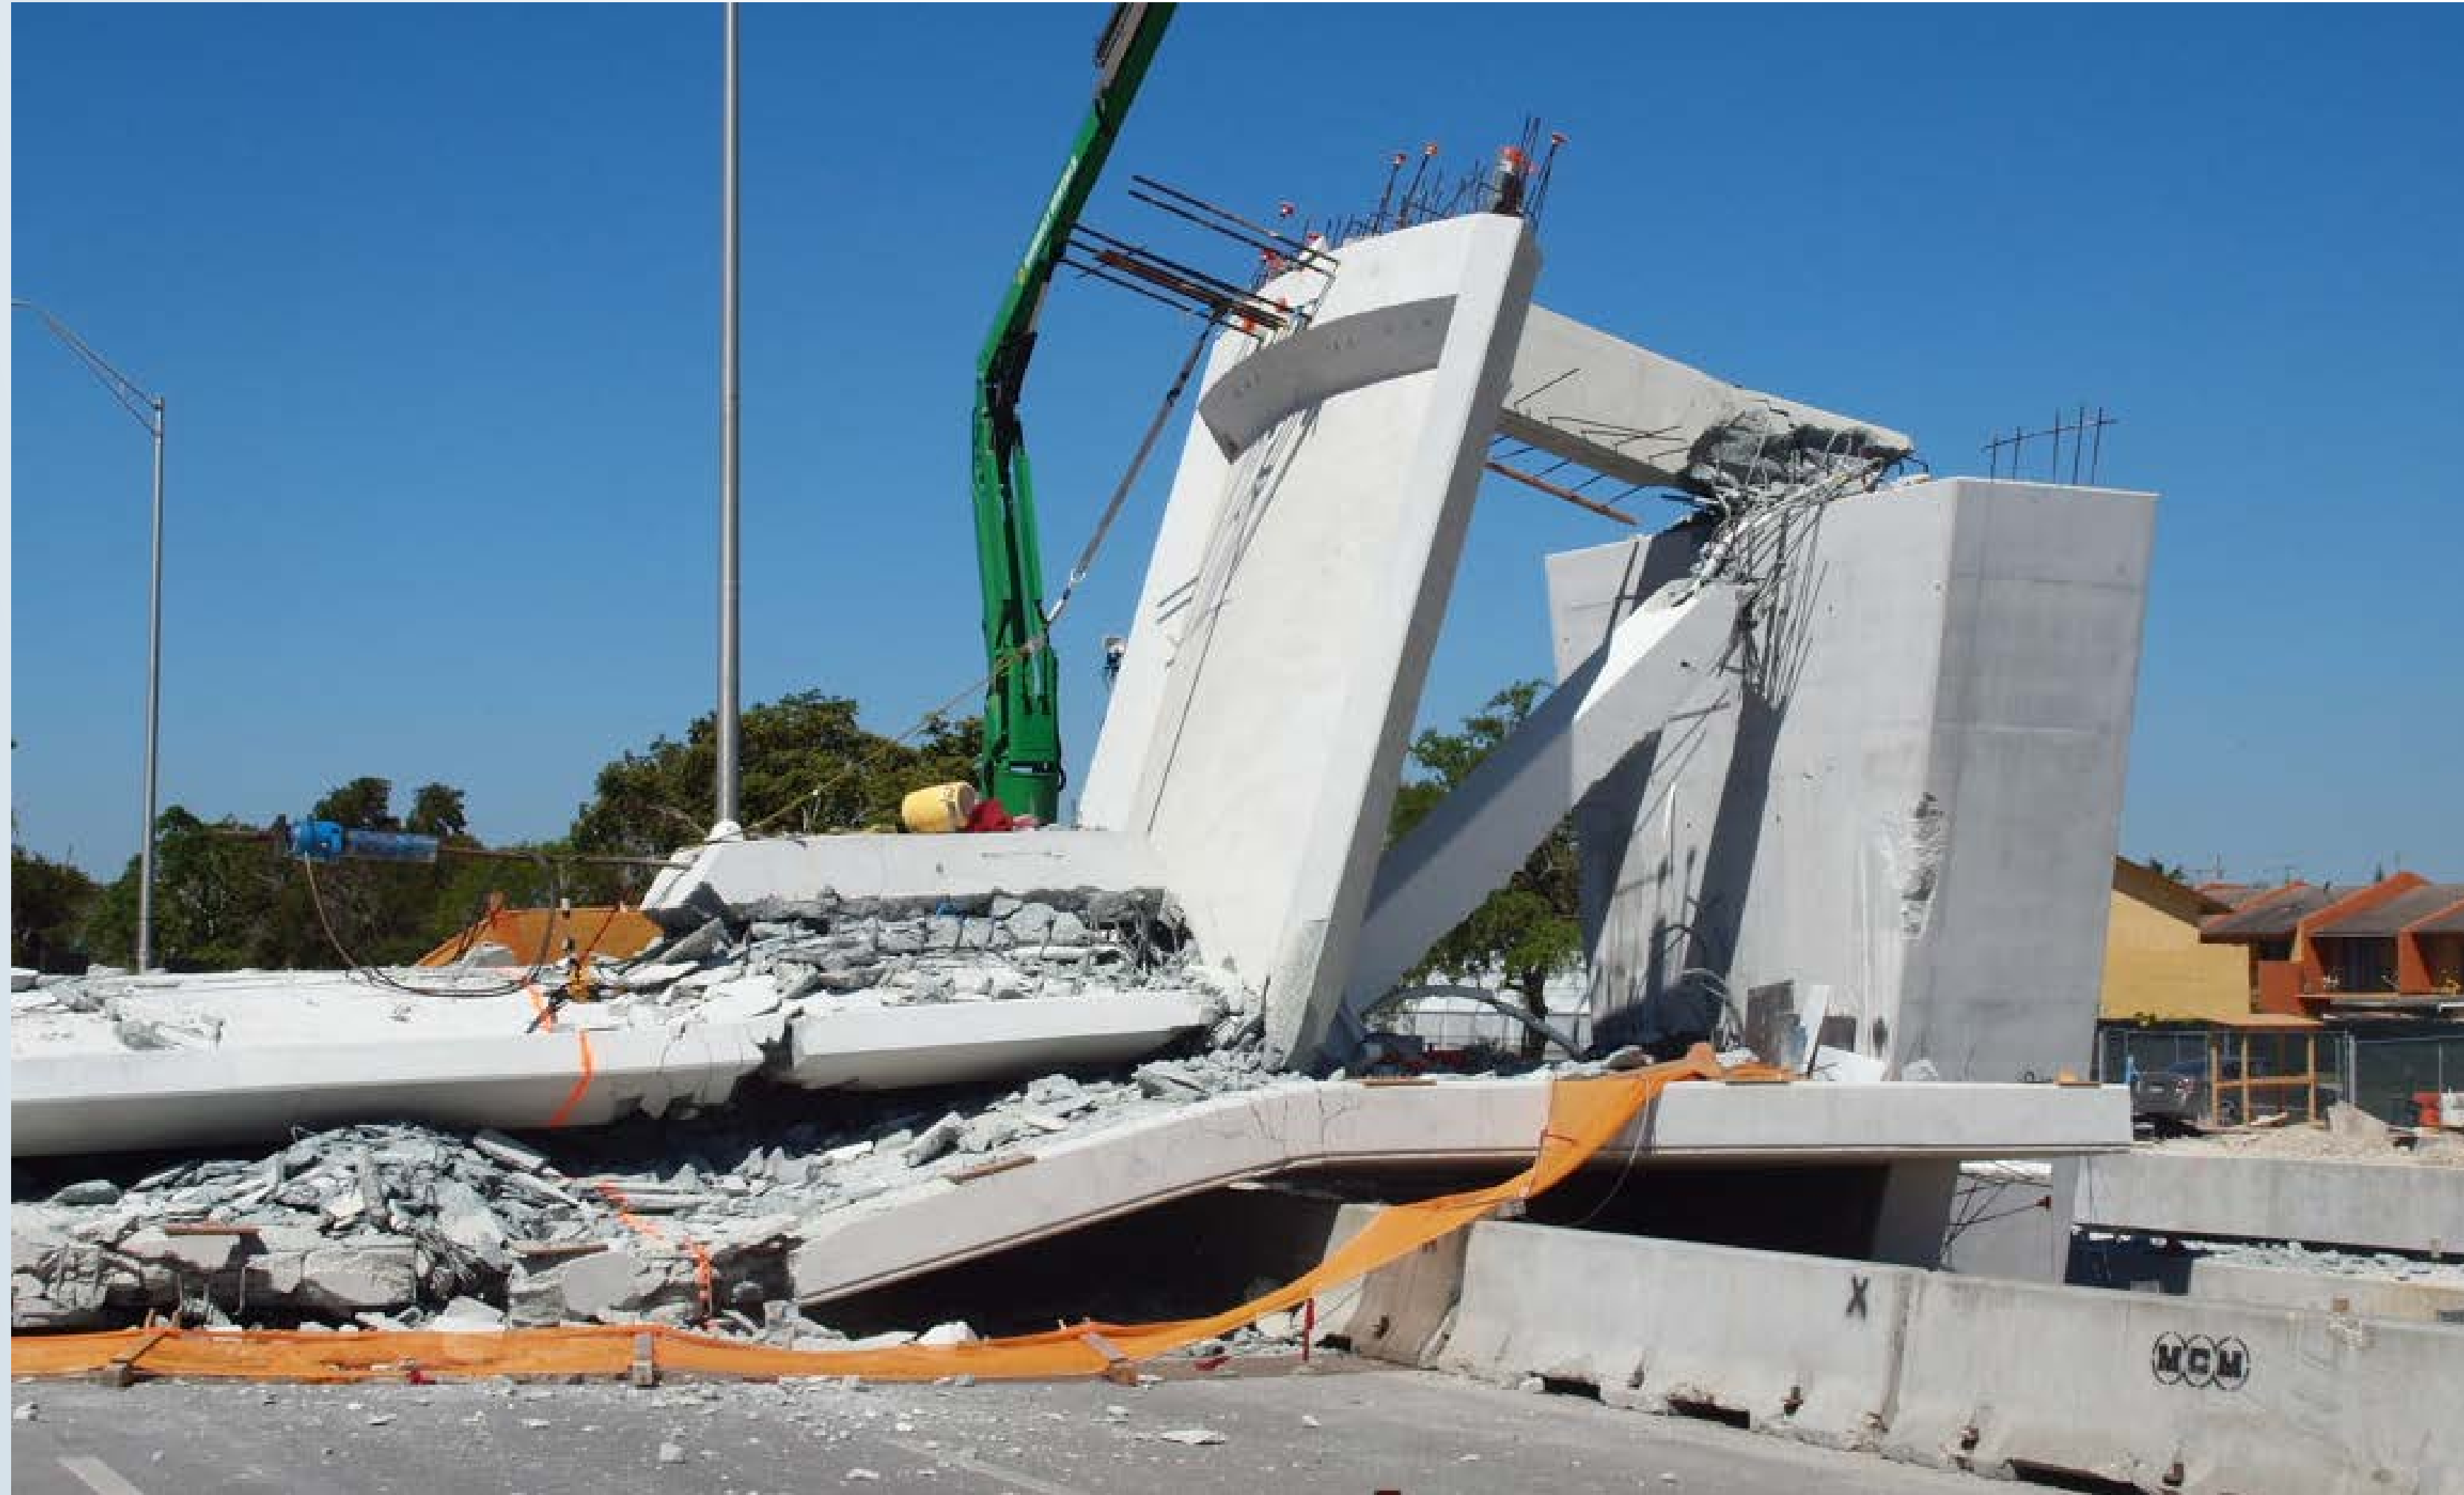
*Collapse: March 15, 2018*

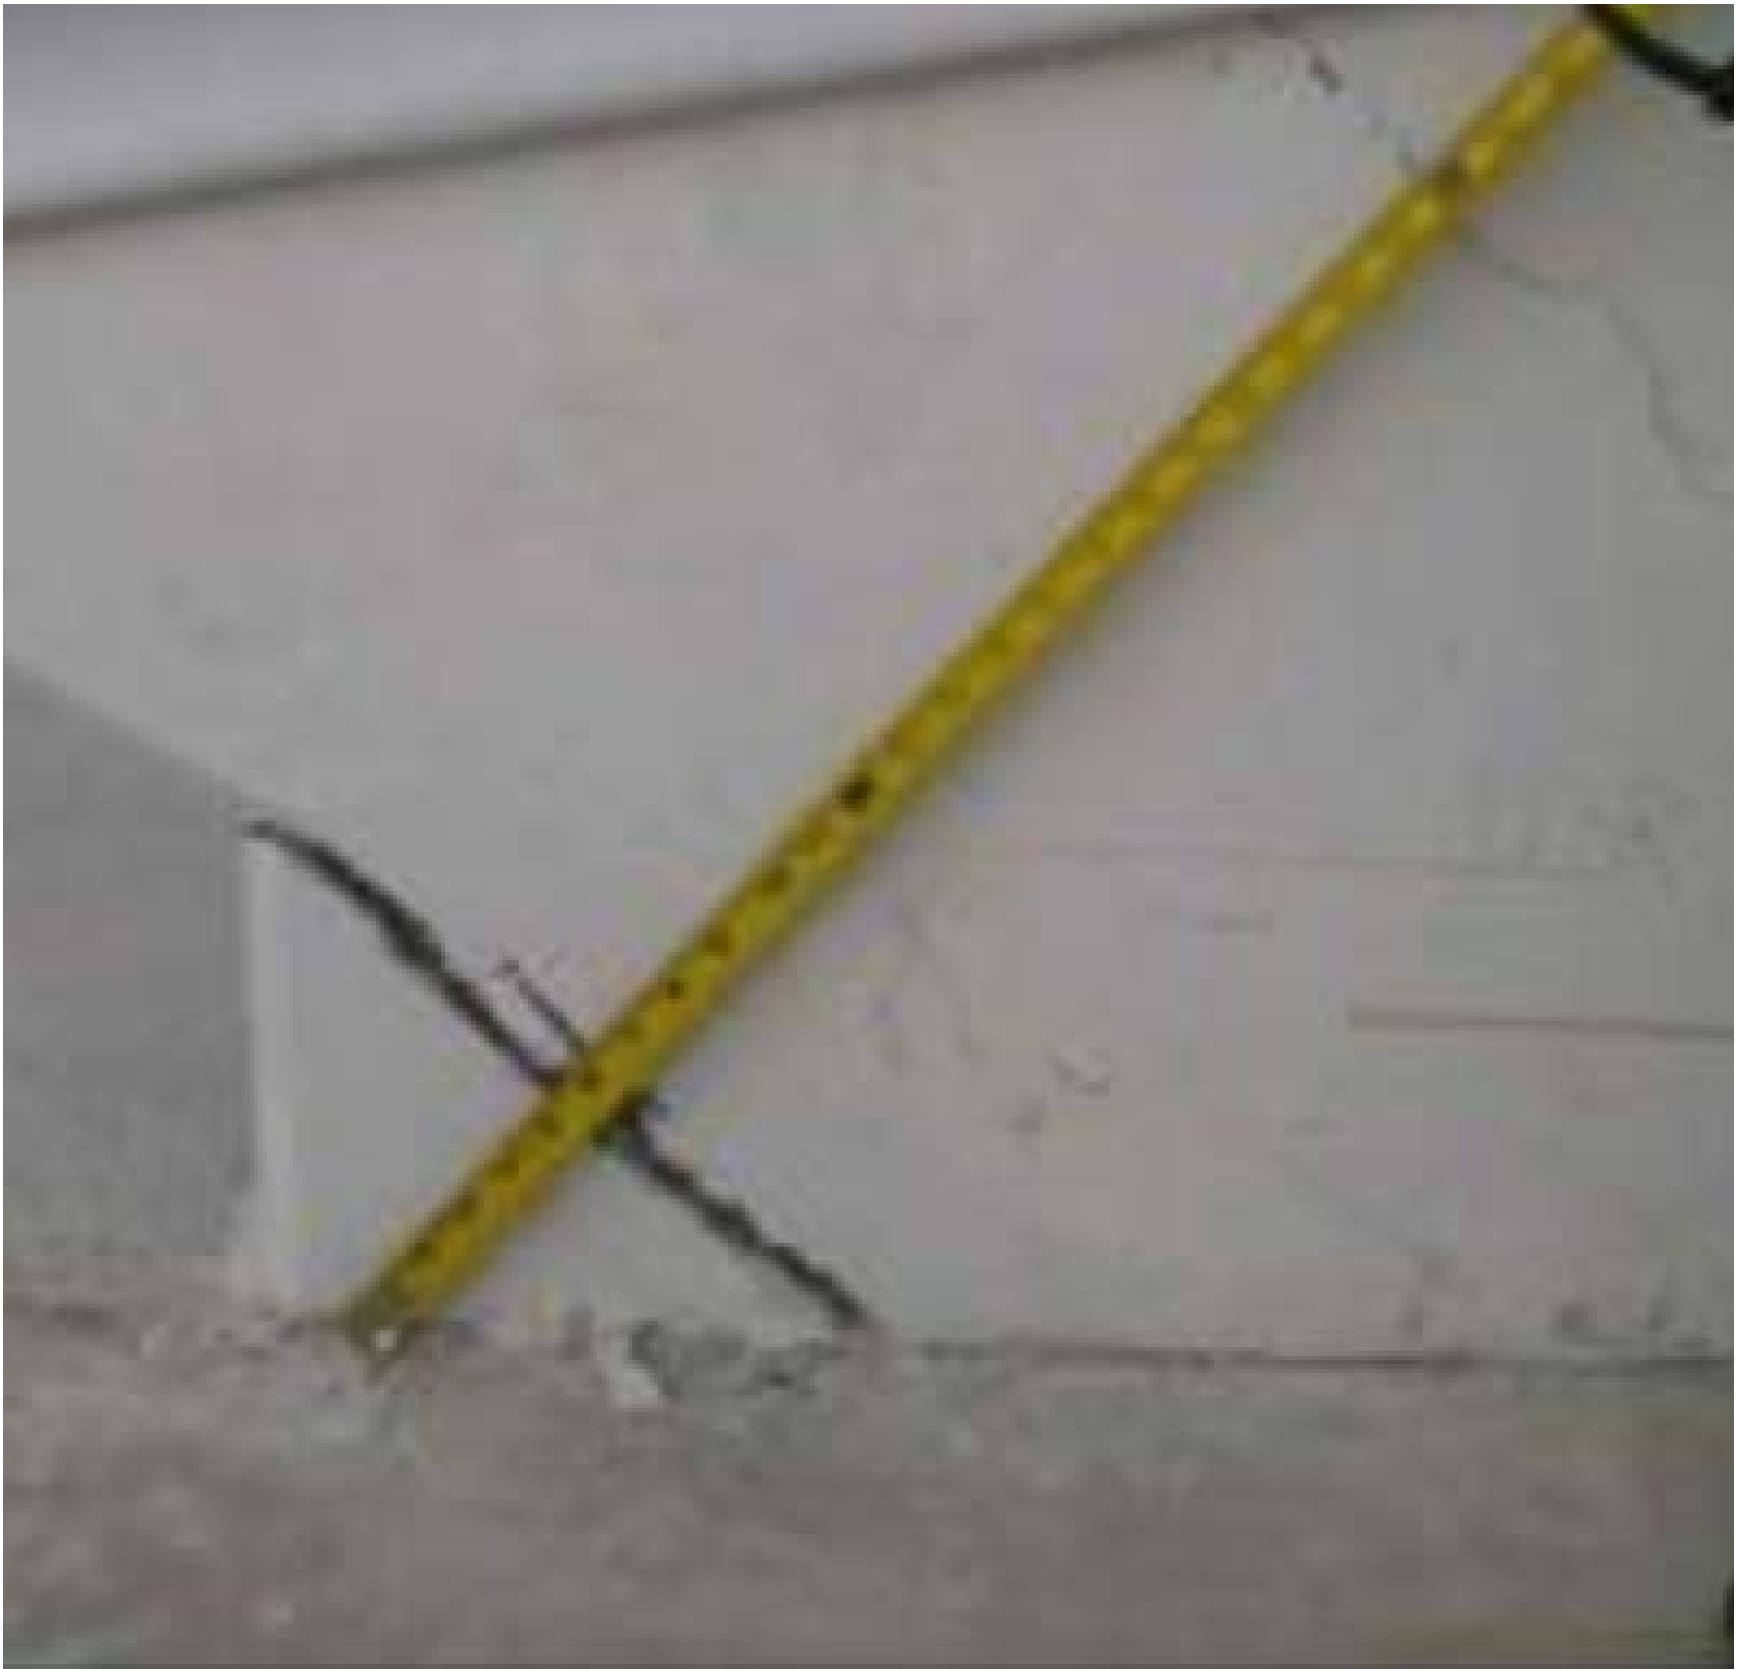
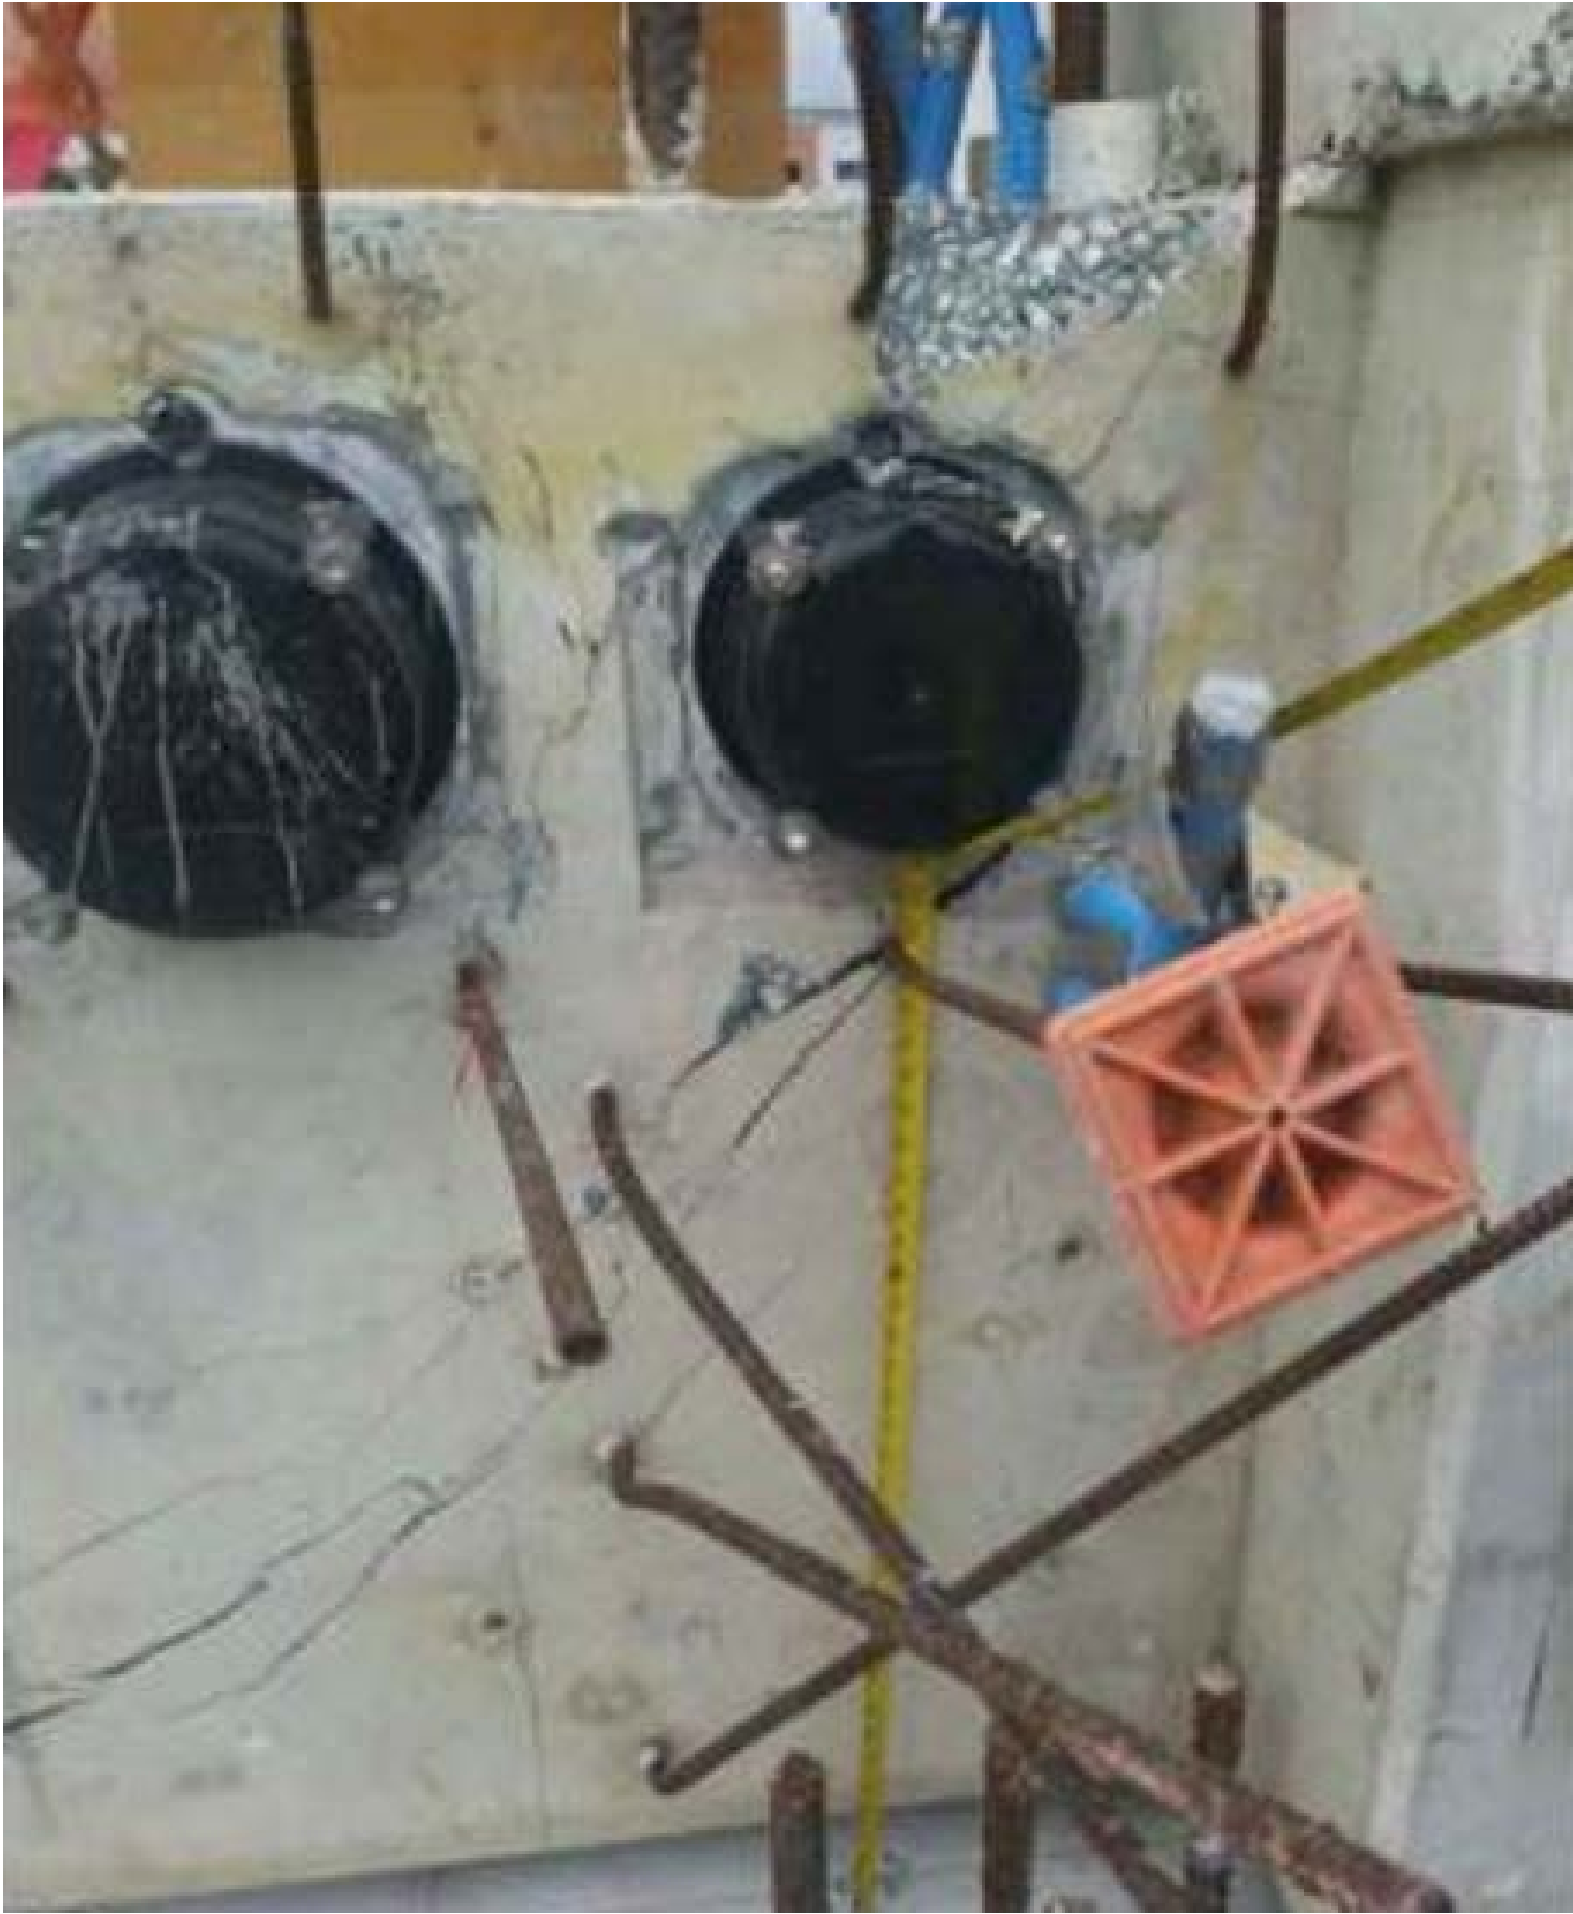
# After Shoring Removal: Feb. 24

# On Final Supports: March 12

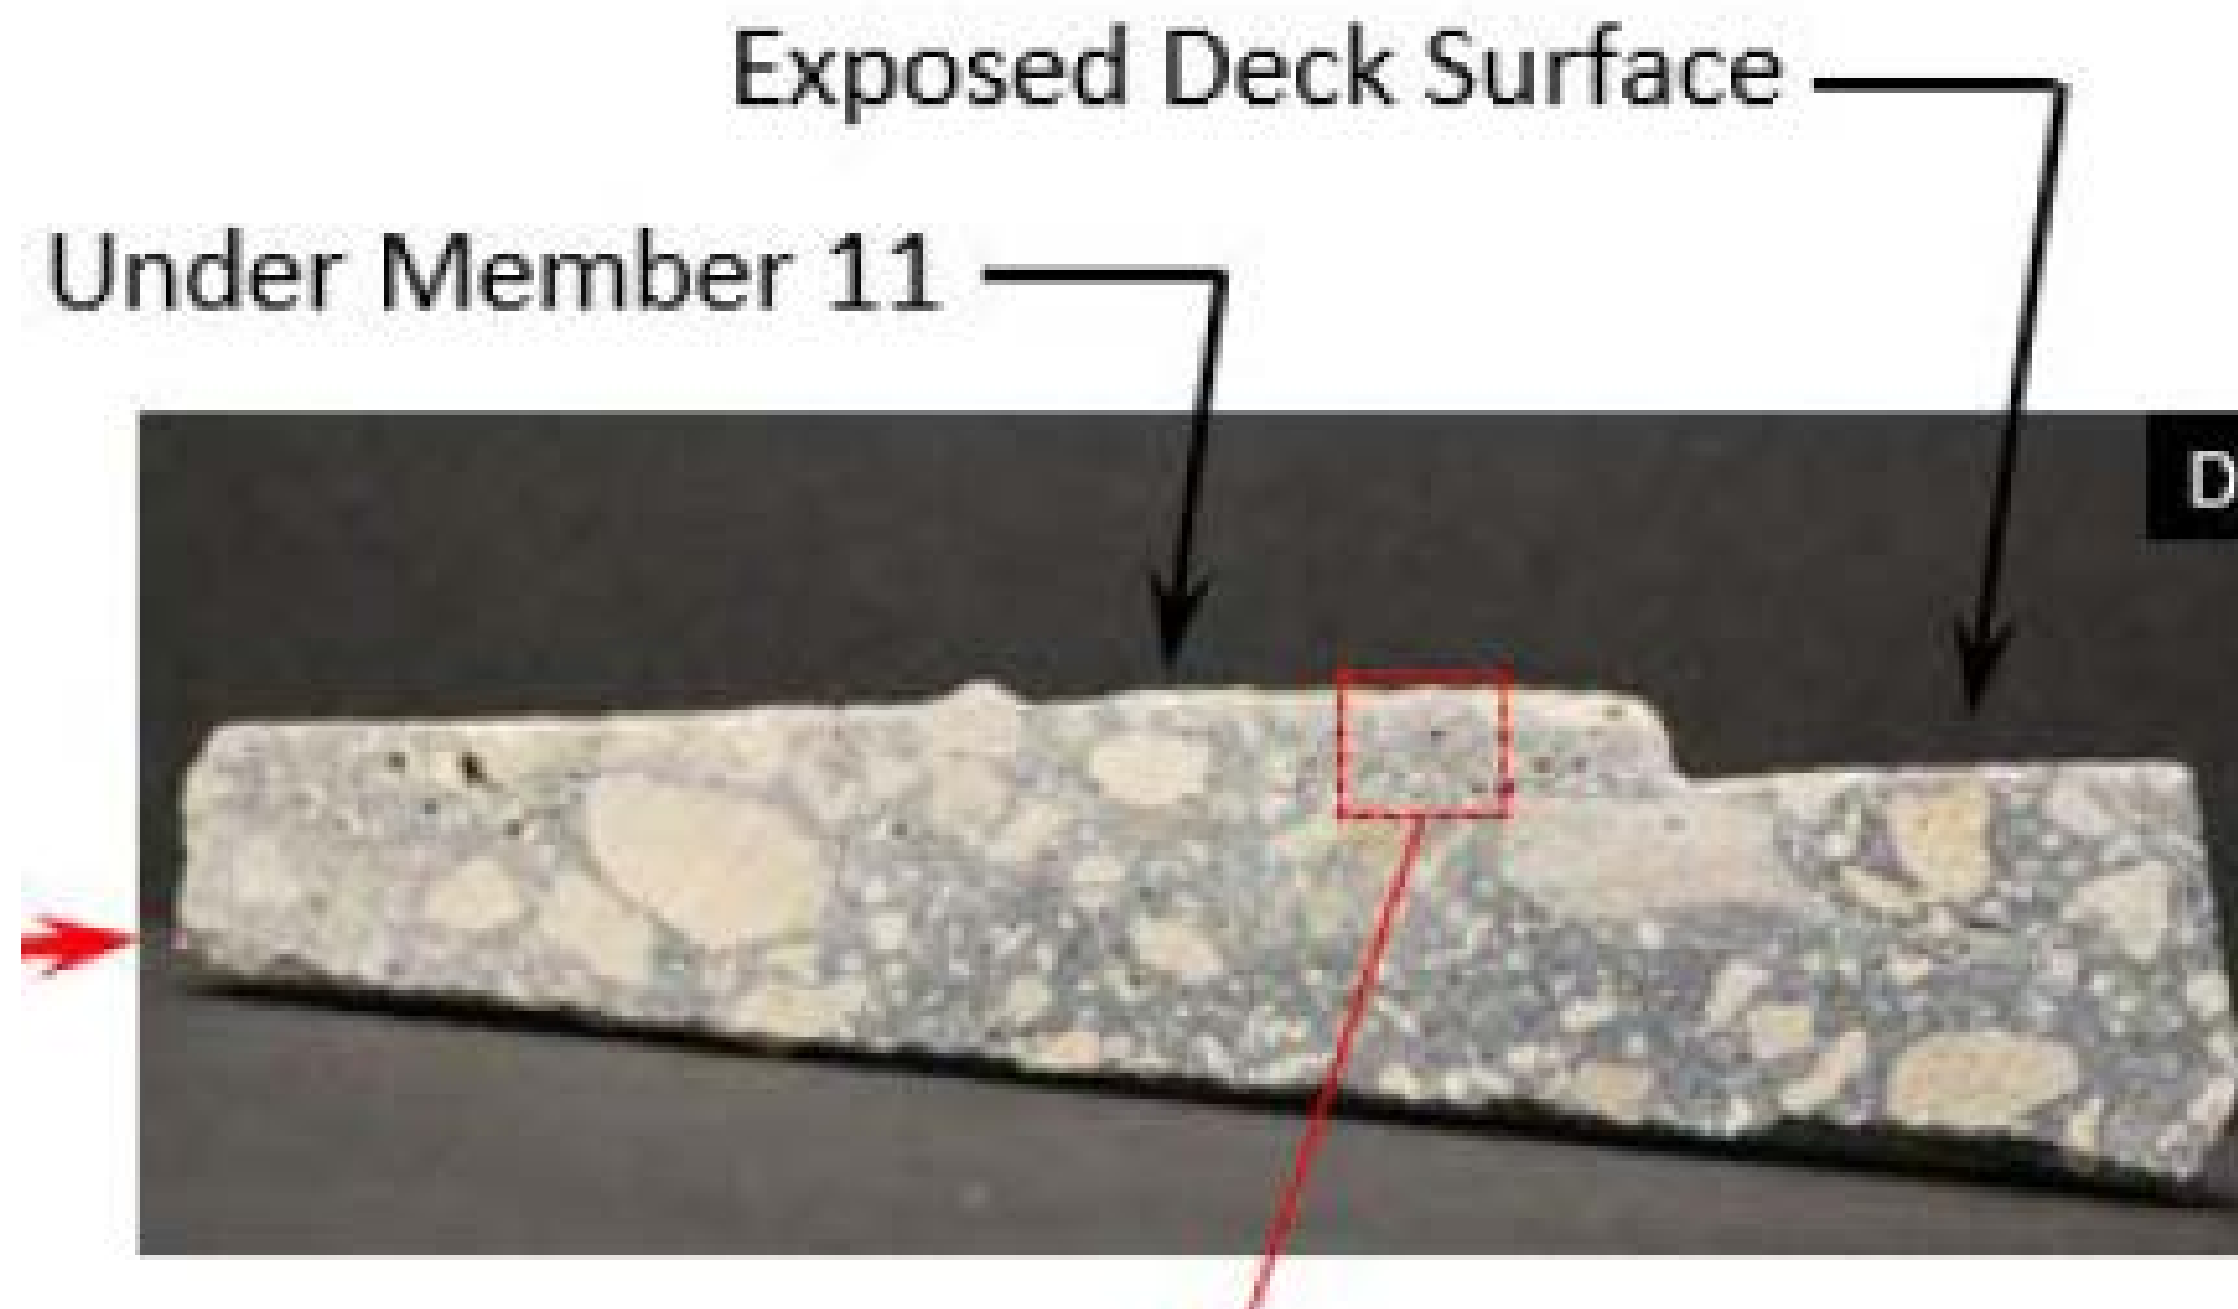
## FHWA Report on Member 11/12 Joint

***FHWA Conclusion: "The evidence indicates that the failure interface coincides with the original cold joint and that the cold joint was not intentionally roughened."***
