# FIU PEDESTRIAN BRIDGE COLLAPSE

## AASHTO Committee on Construction VIRTUAL ANNUAL MEETING

Gary J. Klein, P.E., S.E. – Wiss, Janney, Elstner Associates, Inc.

August 13, 2020

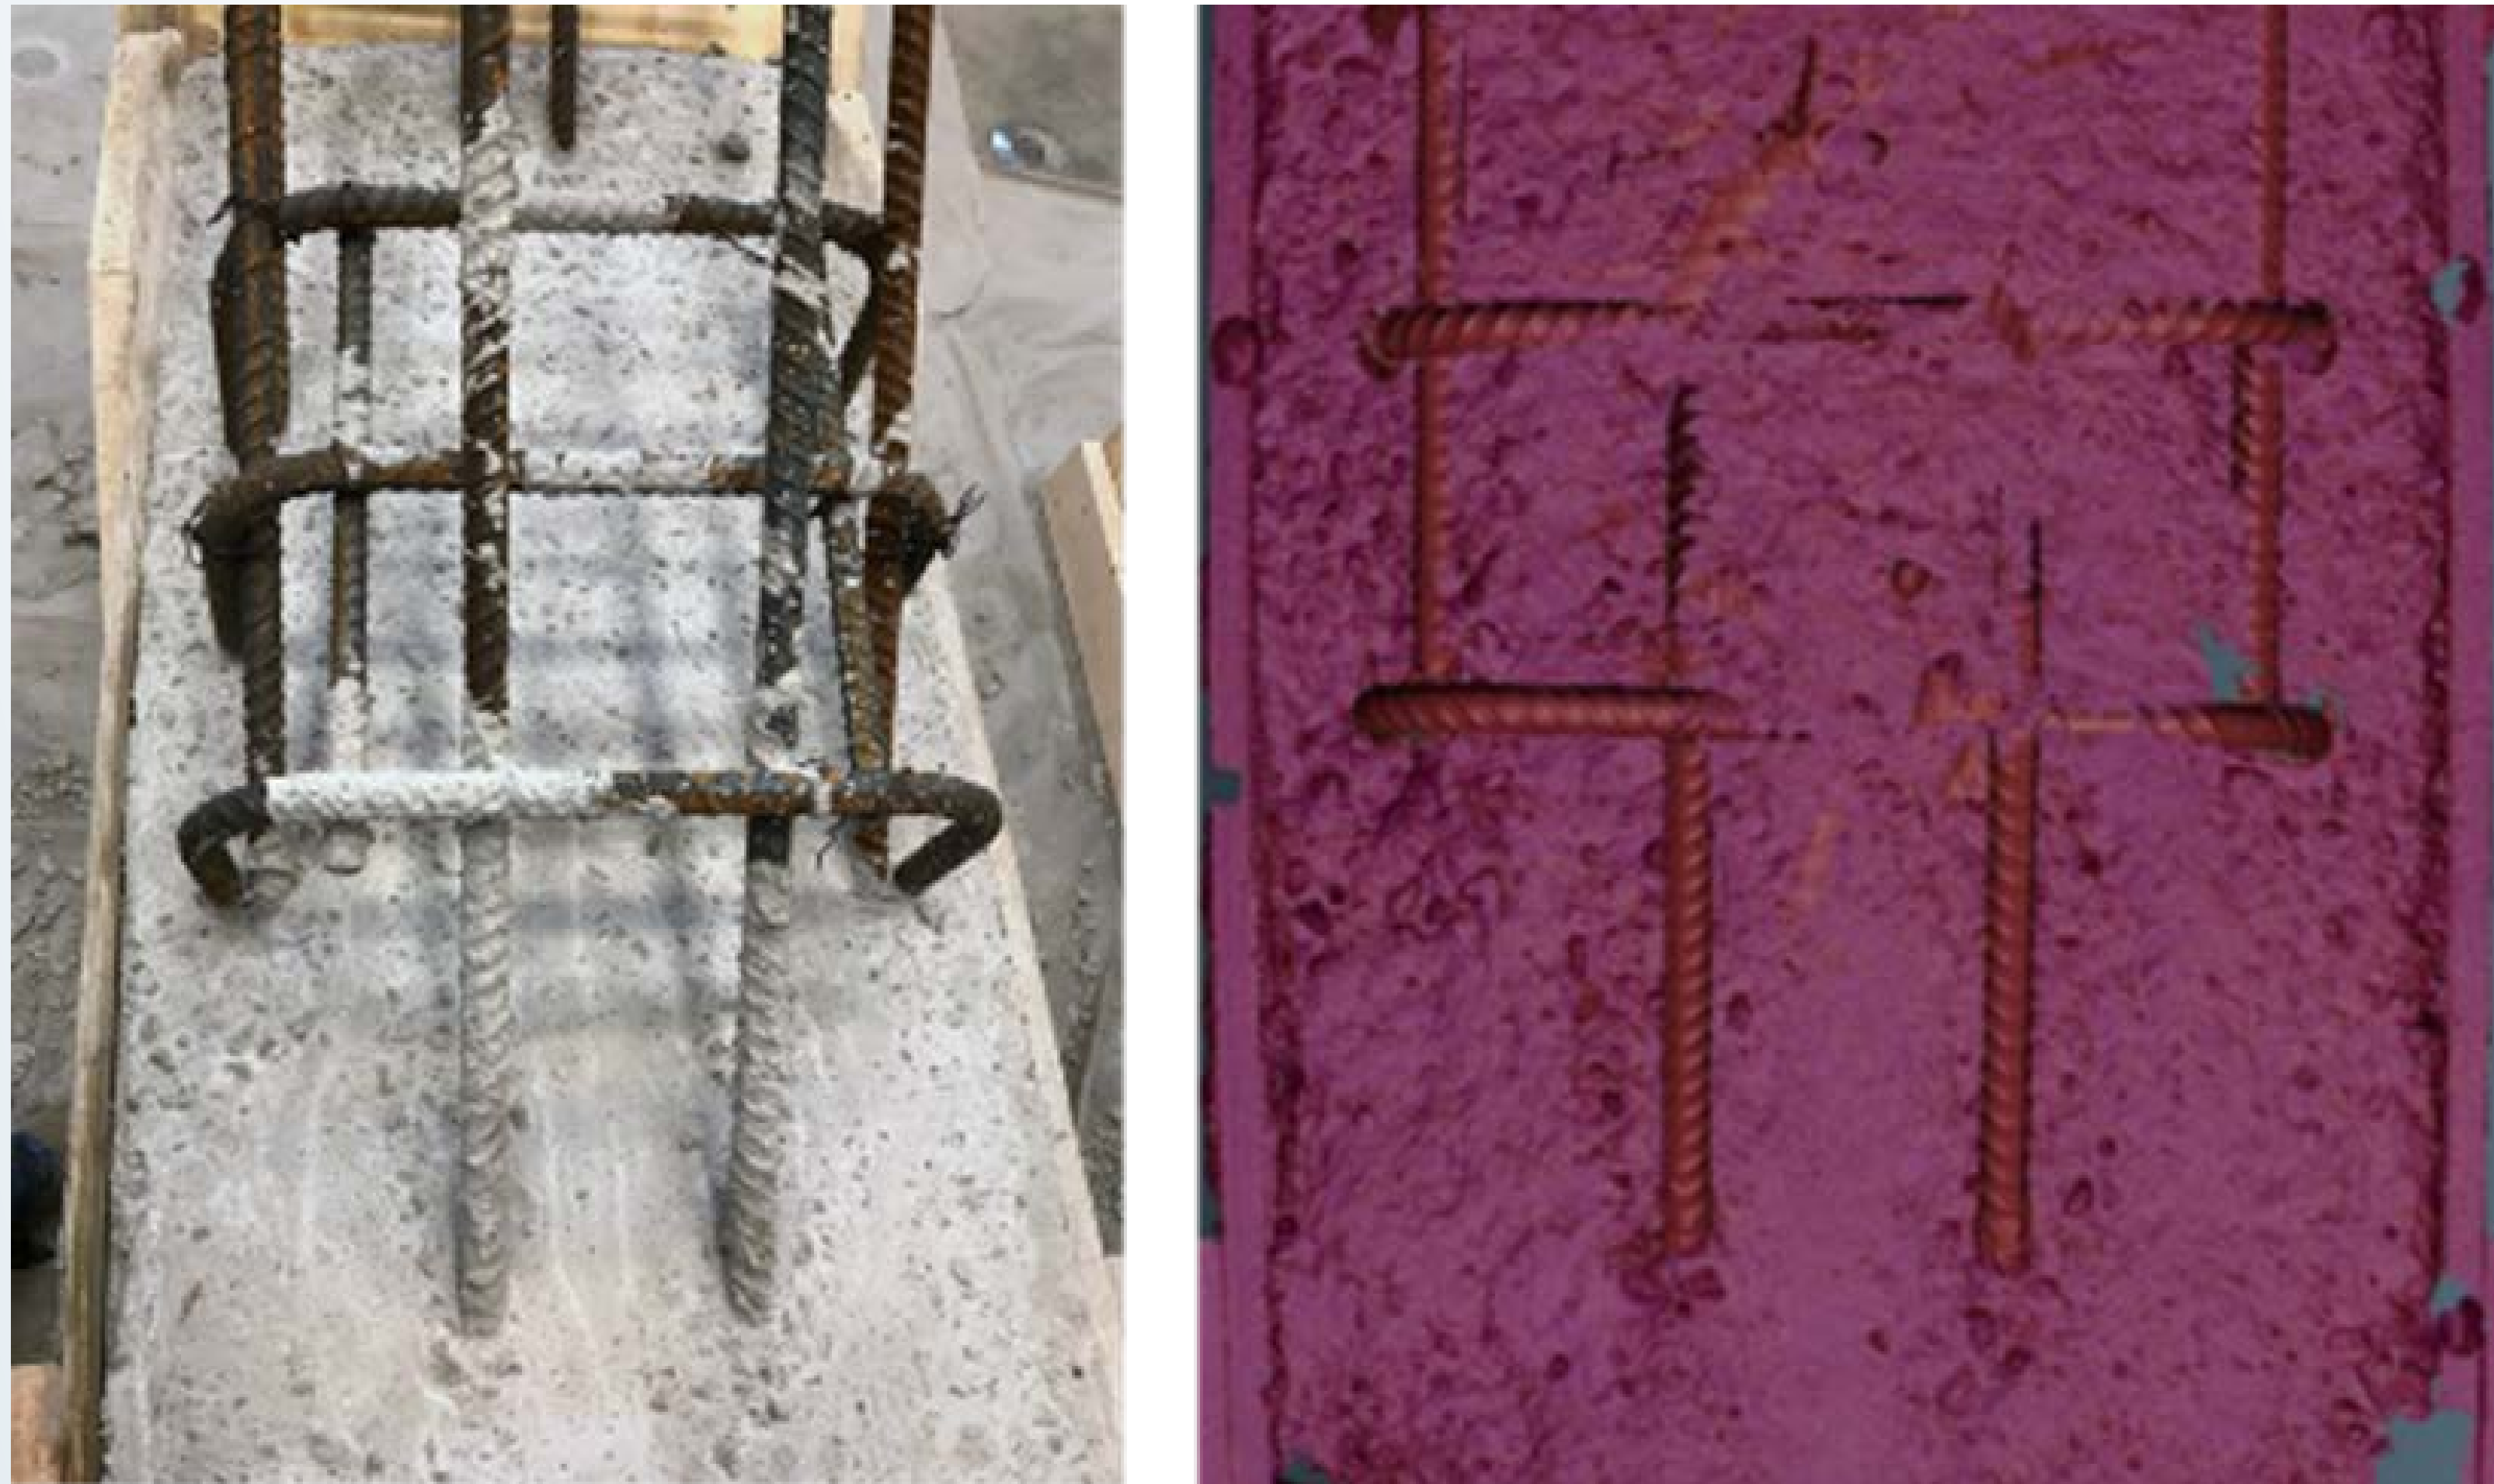
***Photograph and laser scan of WJE Specimen 3 (As-placed)***

Laser Scan Data: Standard Deviation (mm)	
Deck Specimen 1 (recovered by NTSB from site)	0.76
WJE Specimen 3 (as-placed)	0.94
WJE Specimen 4 (intentionally roughened)	2.16

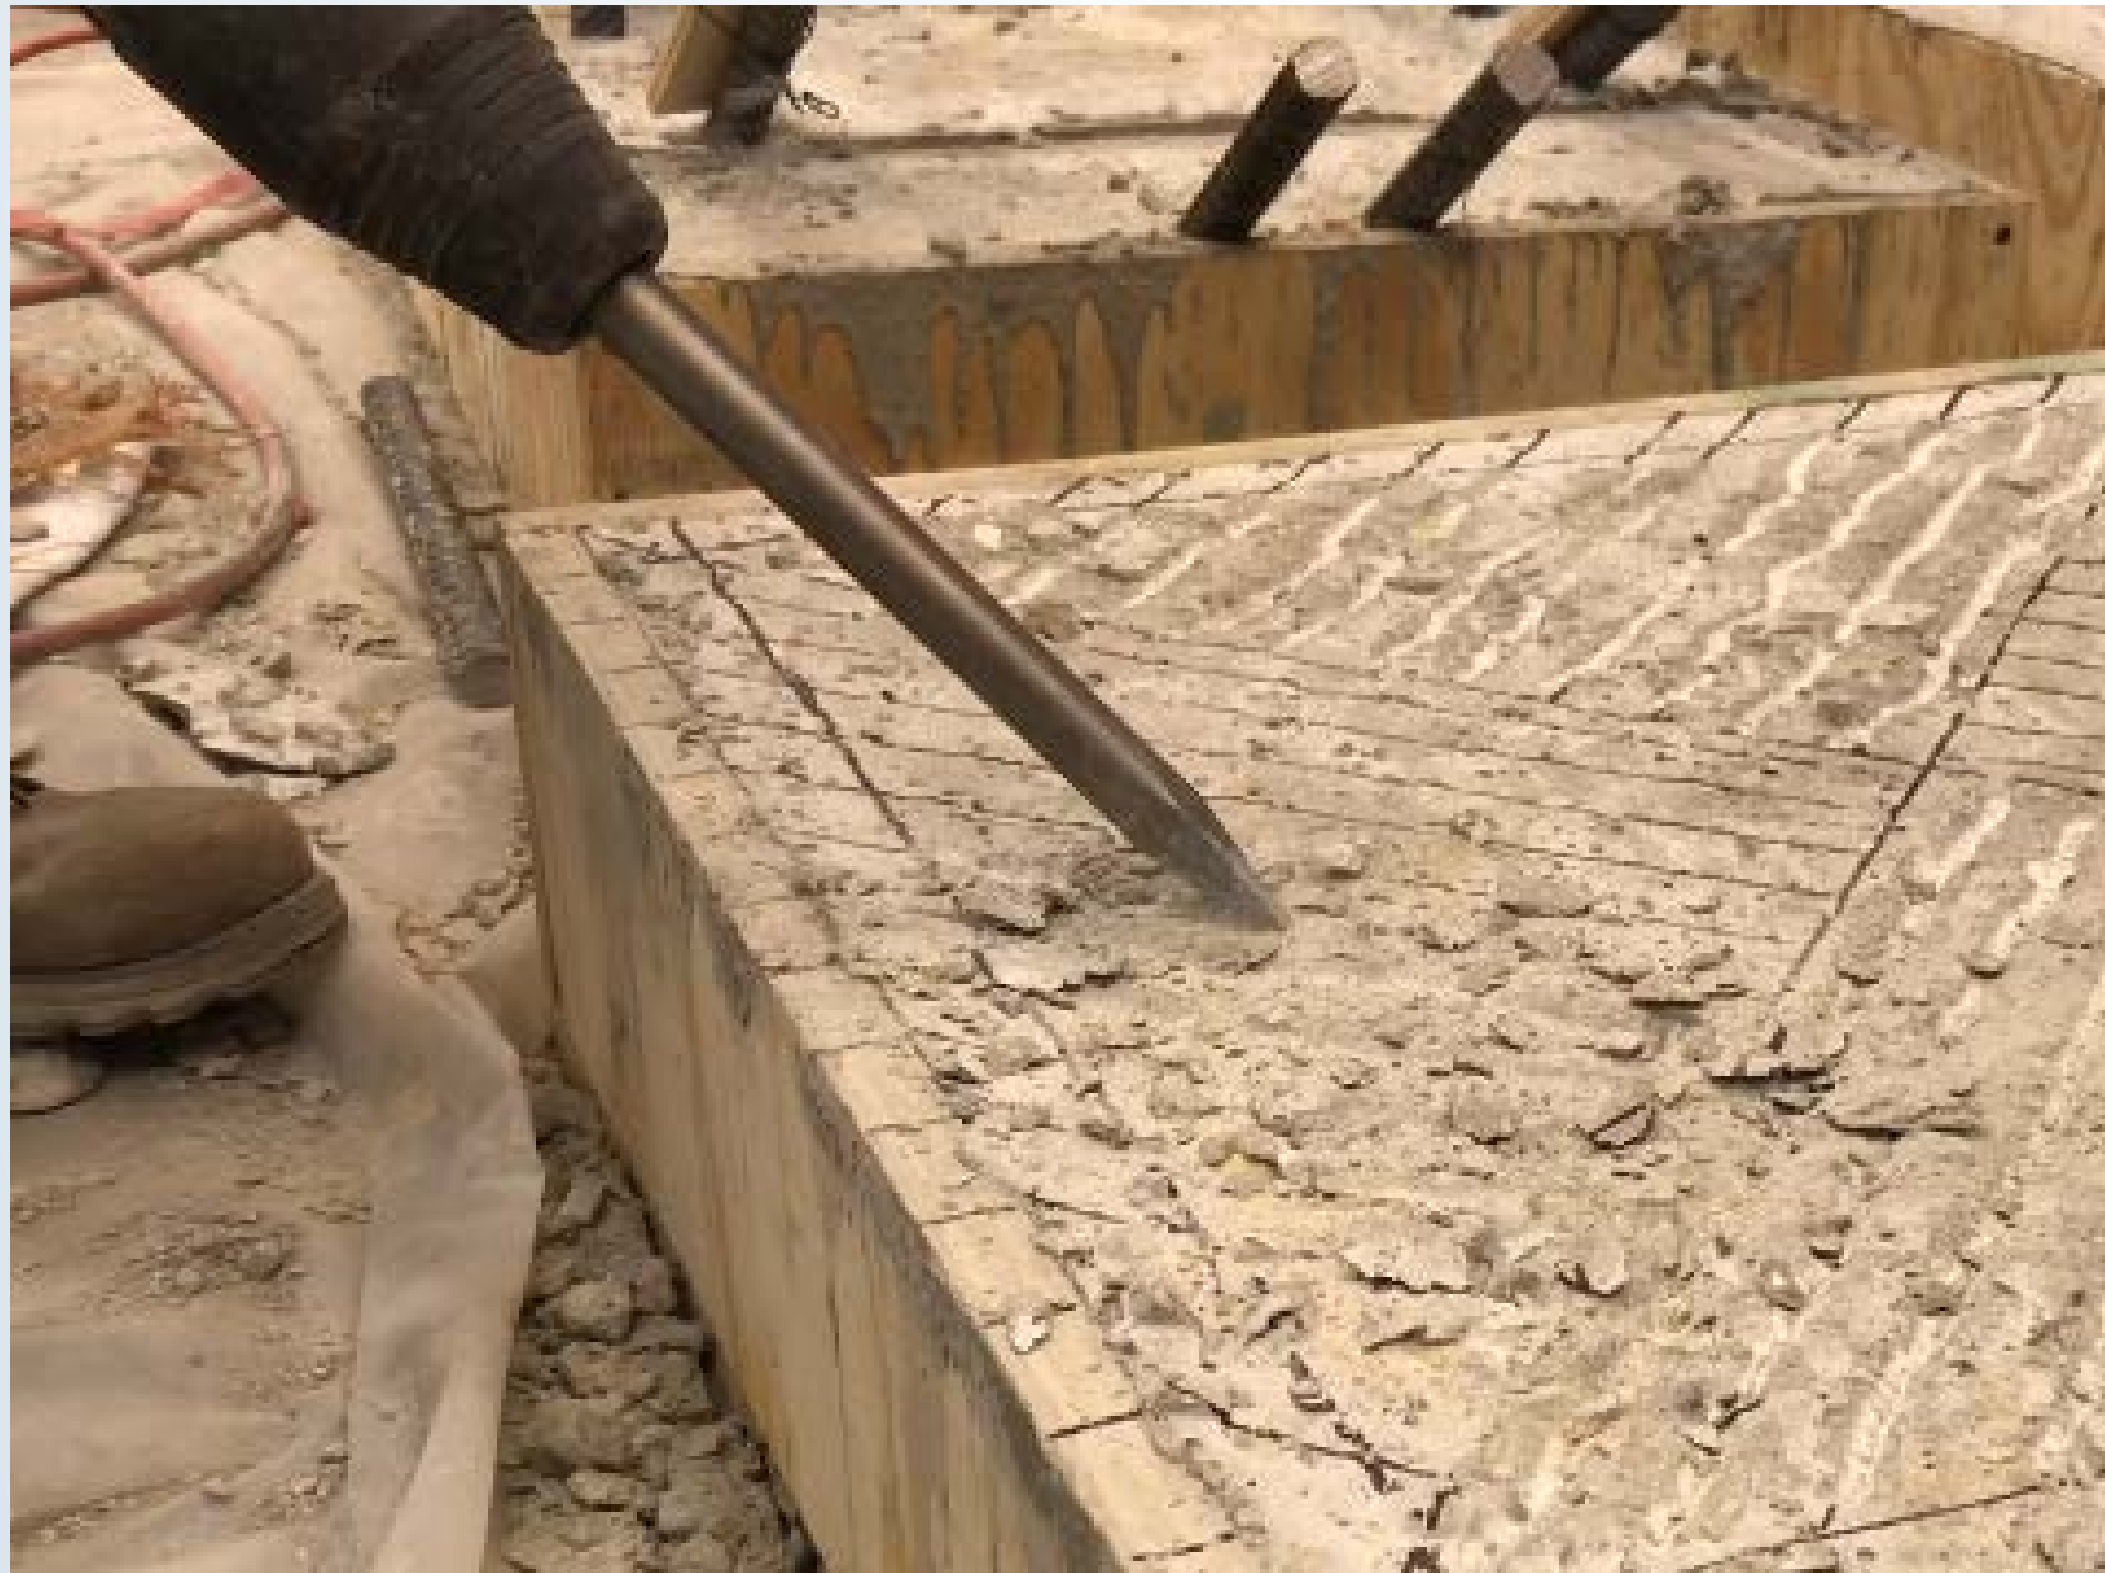
***Surface roughening trials***

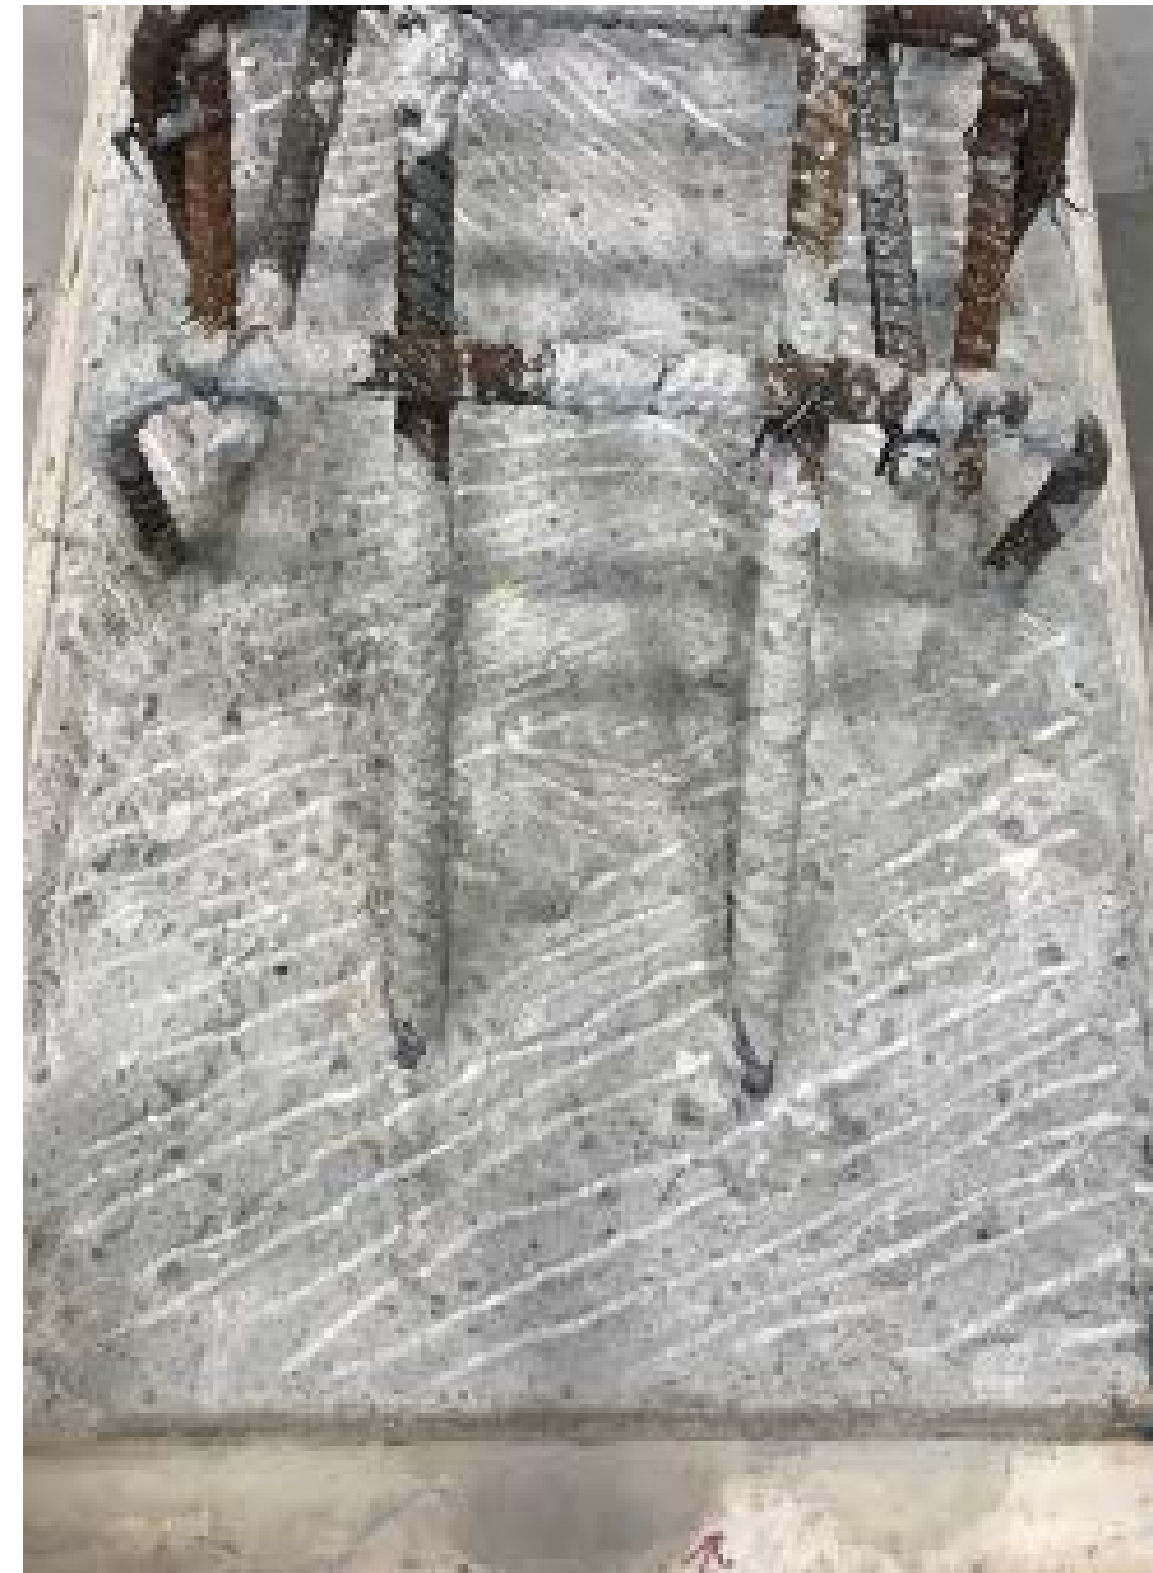
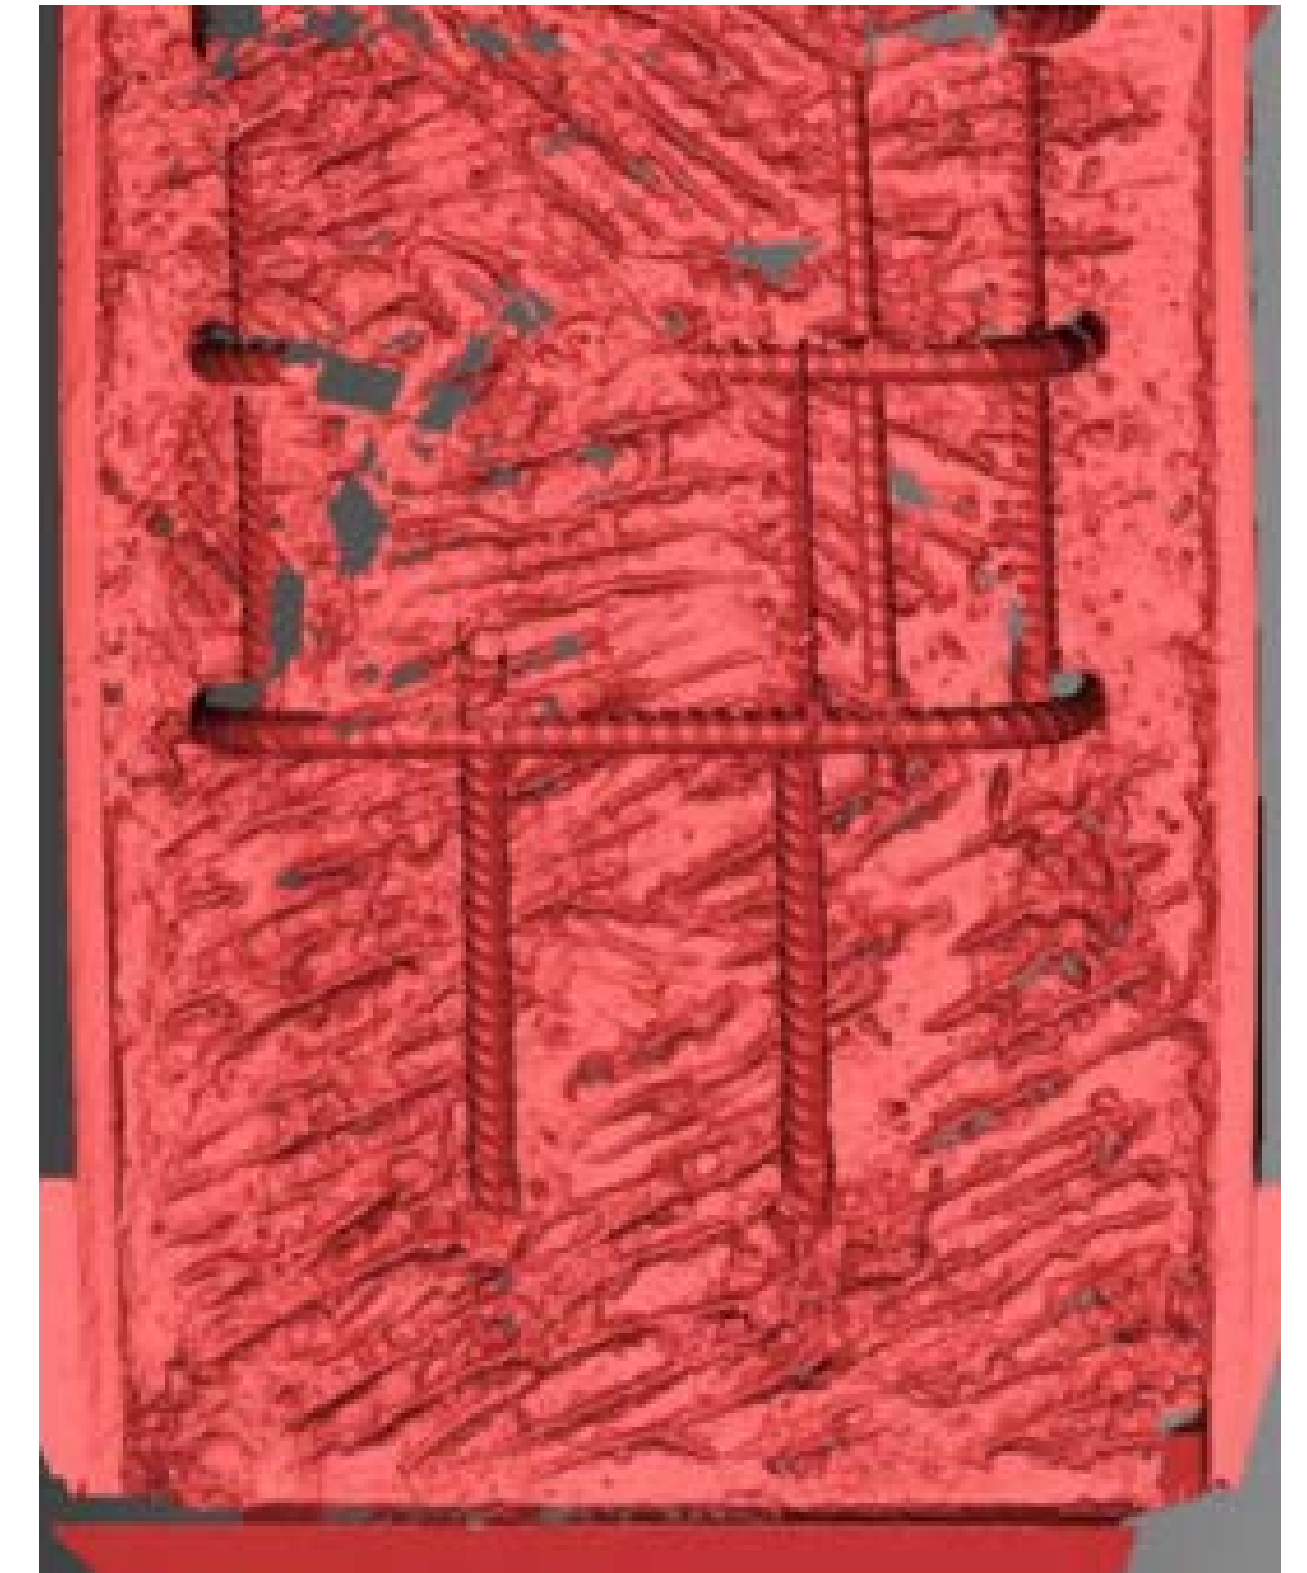
***Photograph and laser scan of WJE Specimen 4  
(Roughened)***

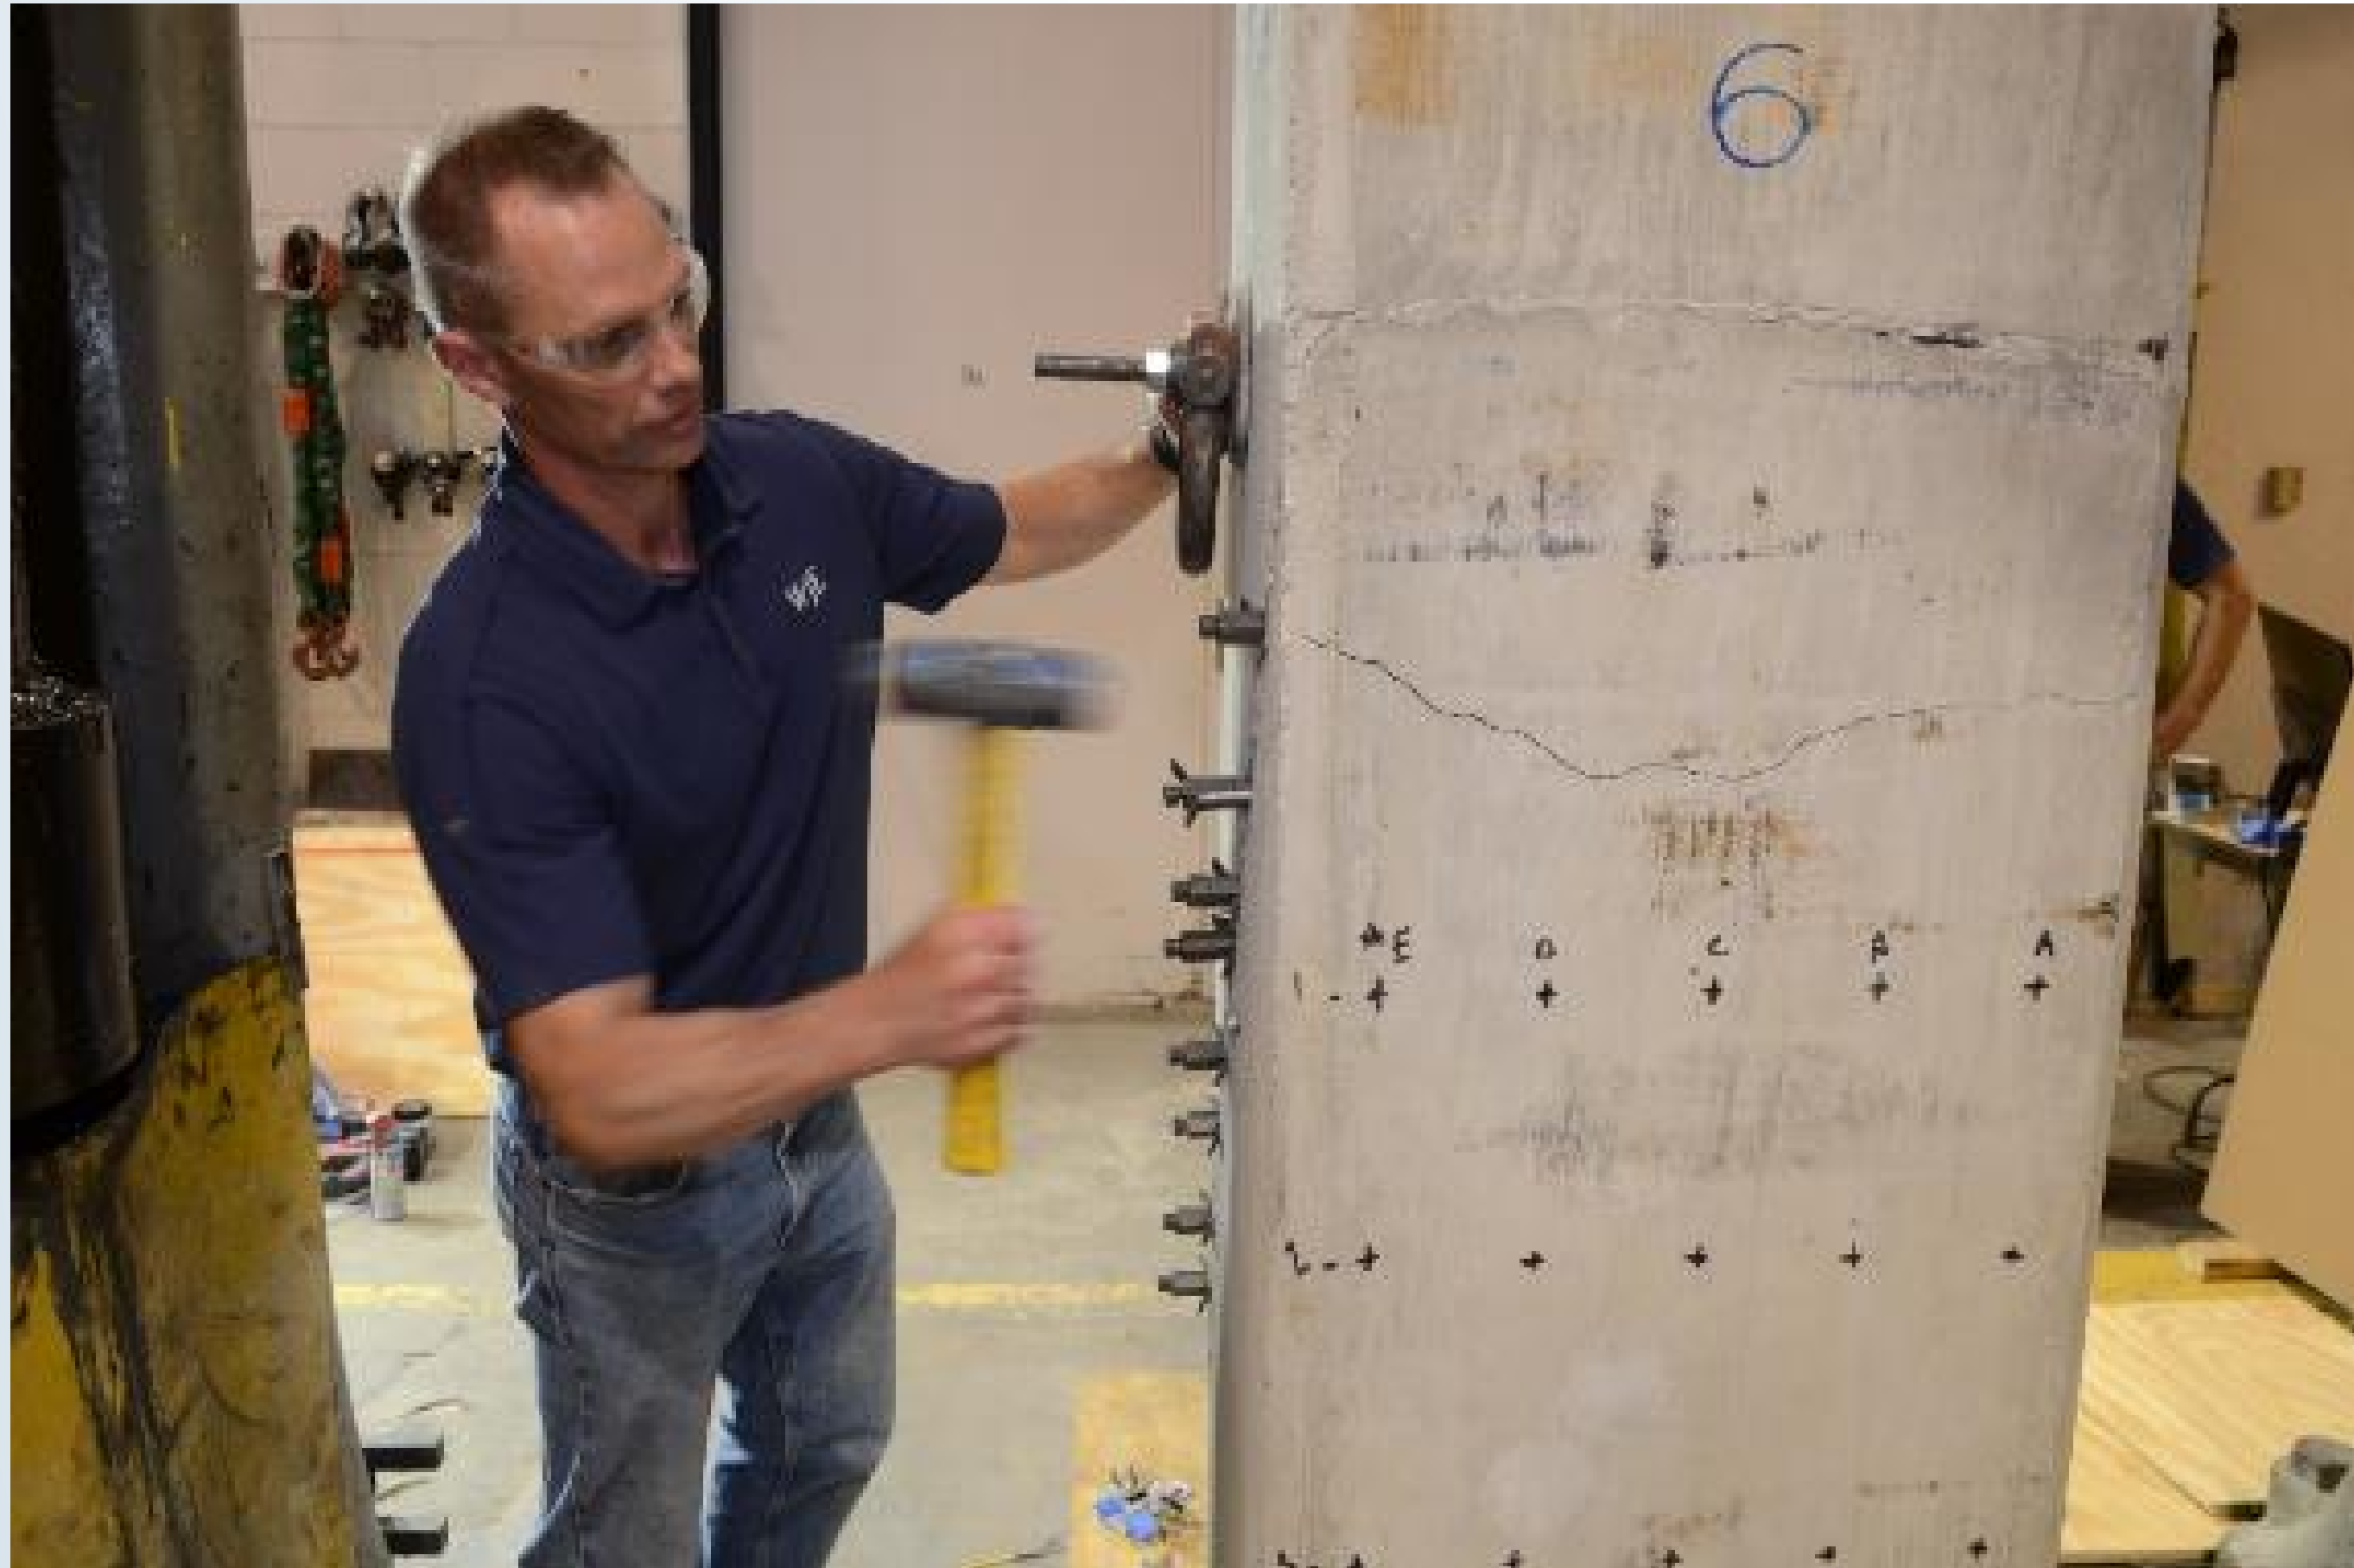
***Stone-splitting wedge sets being used to create a crack across the construction joint of Specimen 6. Most specimens were pre-cracked.***

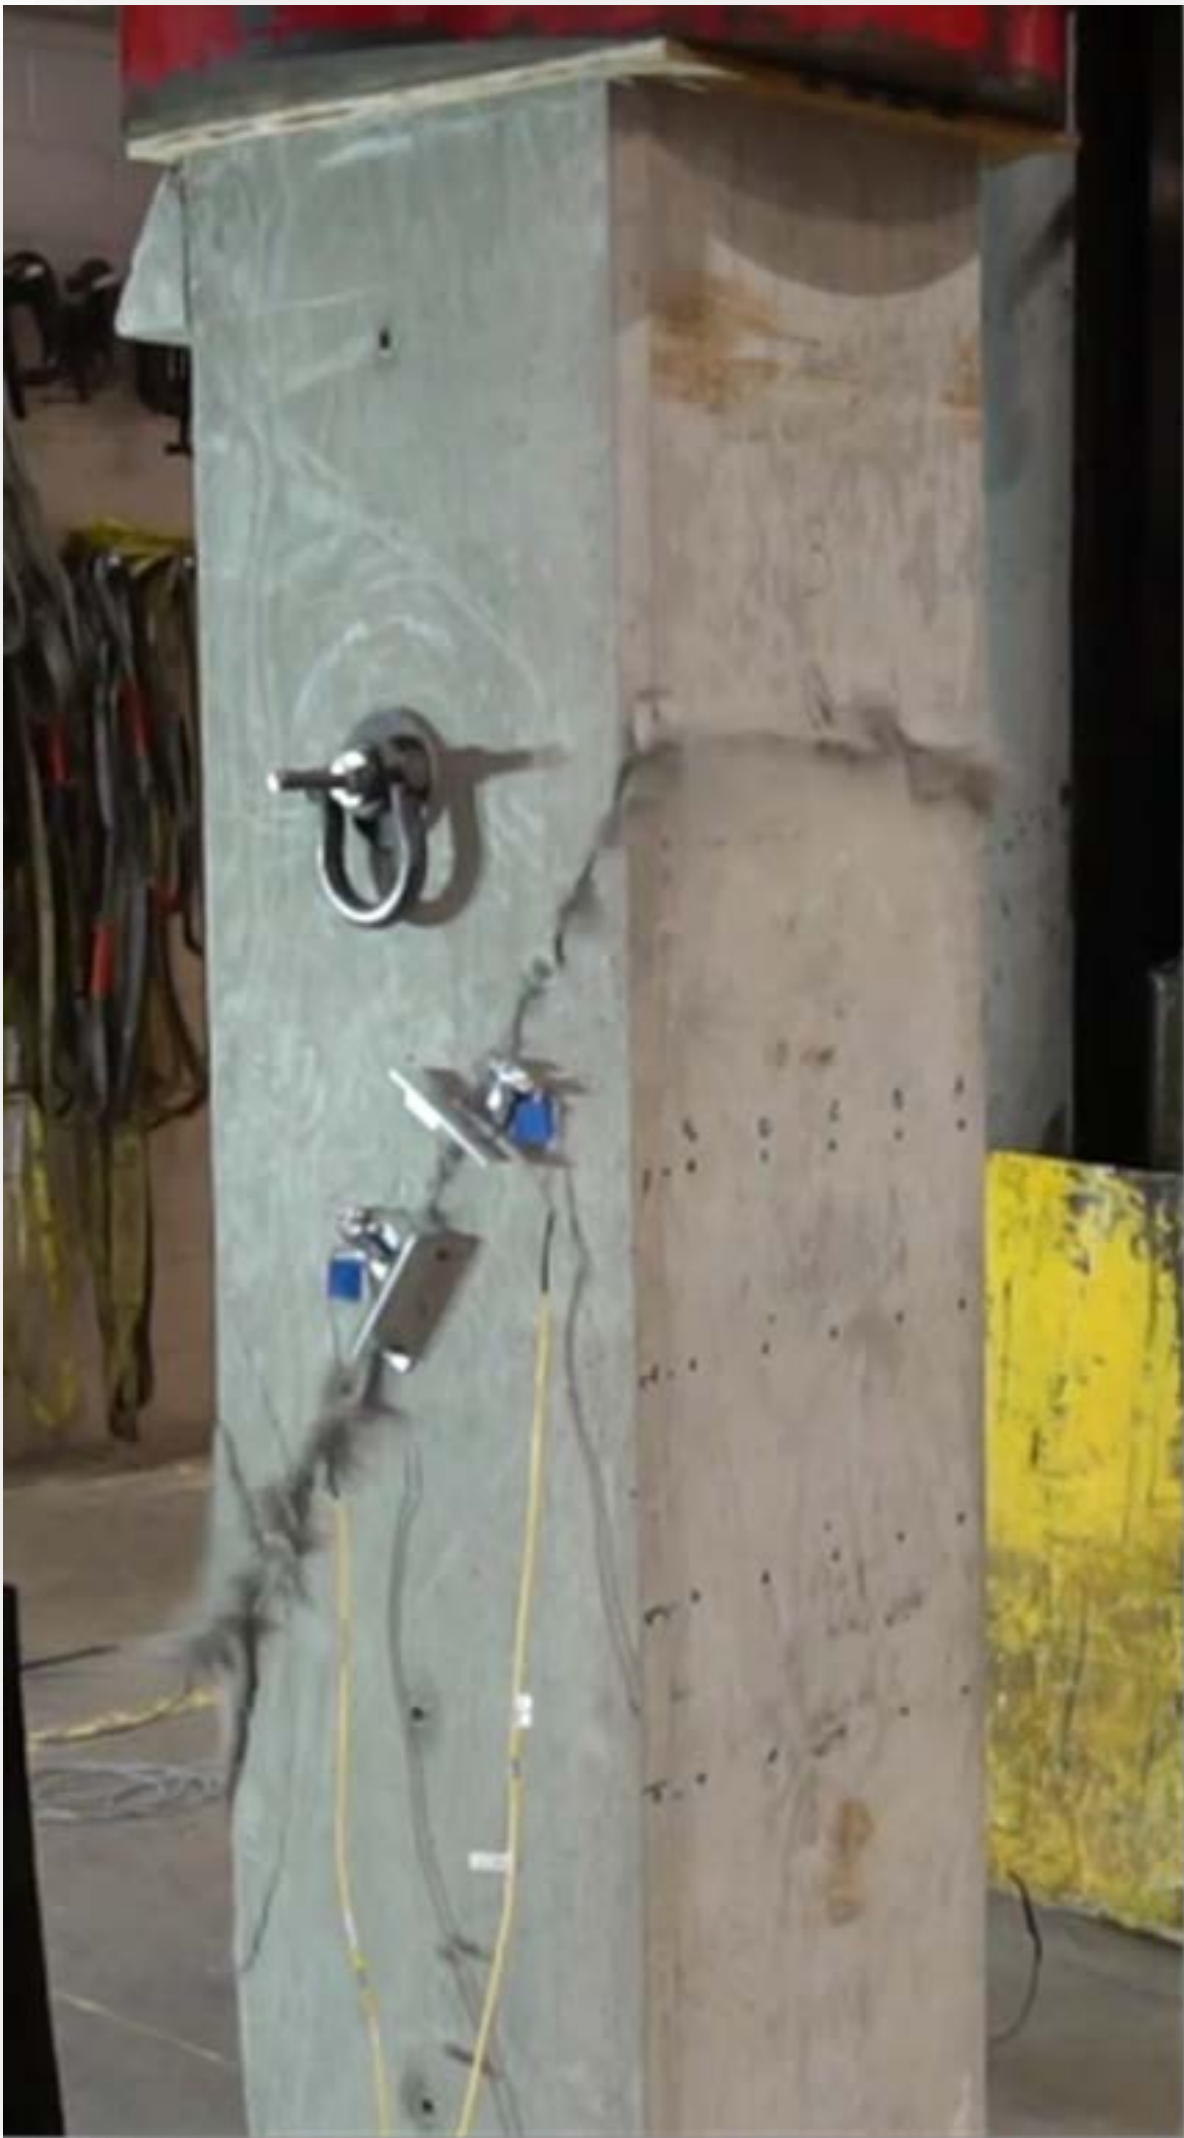
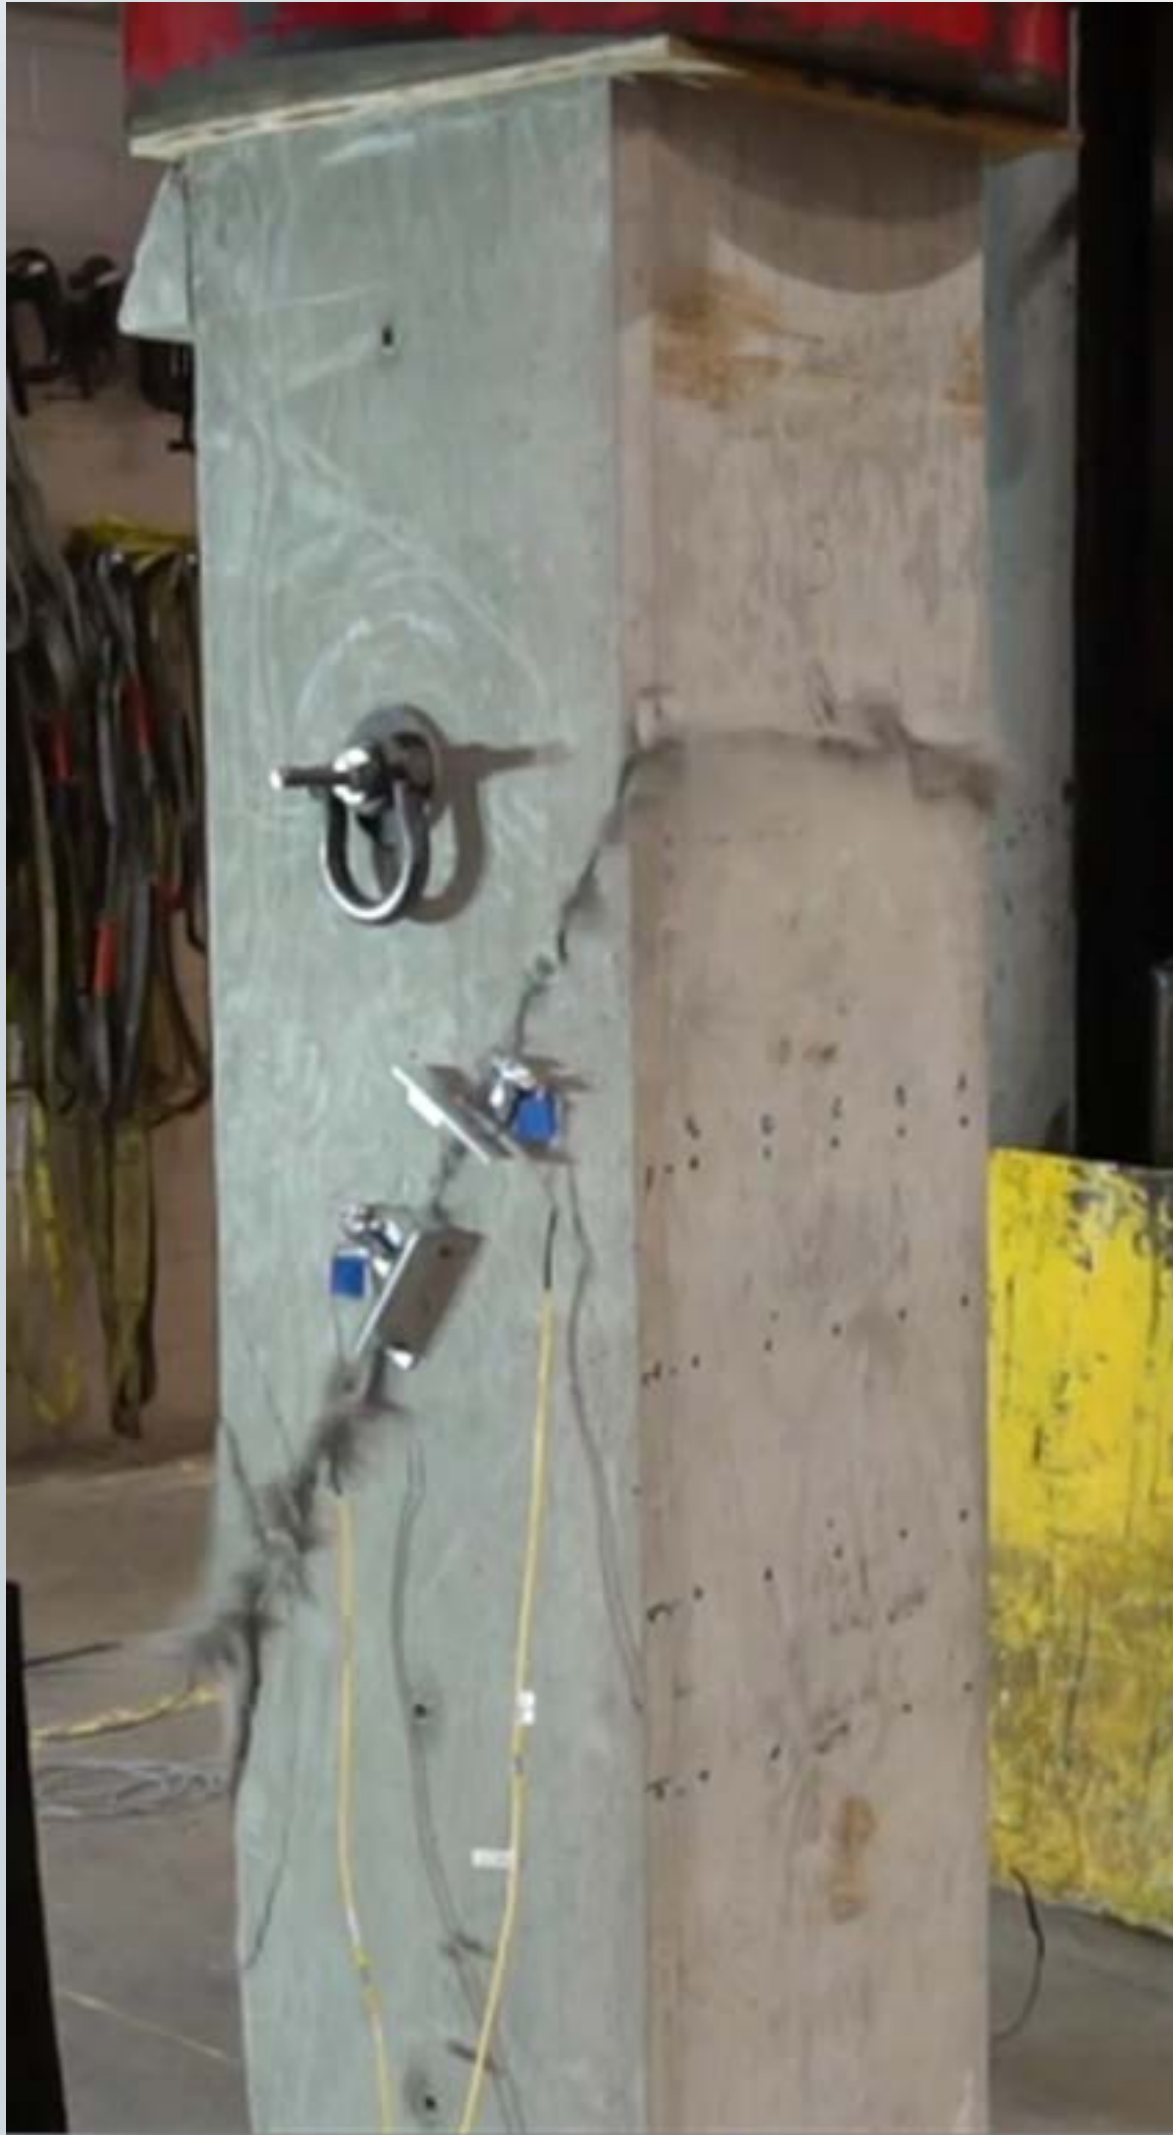
Specimen	Peak Load (Average)	Member 11 Load at Failure	%
Roughened	2,594 kips	1,743 kips	149%
Non-roughened	1,455 kips	1,743 kips	83%

- ***Intentional roughening improved the shear capacity of the cracked interface by a factor of 1.78 compared to the as-placed specimens with a cracked interface.***
- ***If the construction joint were roughened as required by the project specifications, which were reconfirmed by email, the collapse would not have occurred.***

Unless otherwise specified in the contract documents, horizontal joints may be made without keys, and vertical joints shall be constructed with shear keys. Surfaces of fresh concrete at horizontal construction joints shall be rough floated sufficiently to thoroughly consolidate the surface and intentionally left in a roughened condition....

- *Specifying method for measuring surface roughness where ¼ inch amplitude is specified.*
- *Allowing 1) roughening of plastic concrete (followed by abrasive blast cleaning) or 2) roughening of the hardened concrete in a manner that does not damage surface.*
